# Inspection Report

100 My Dream House Lane  
City of Dreams NJ 99999

**Safeway Home Inspections**

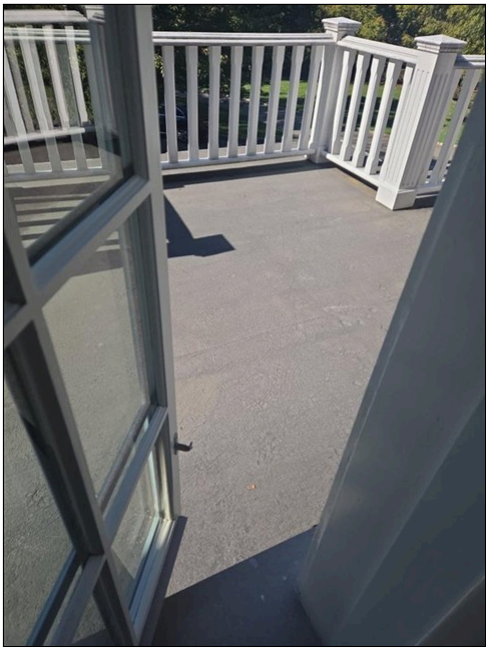
1.0 Item 1(Picture)

The flat roof covering appears to be older and showing signs of ageing such as granule loss and general weathering. While no immediate failures were observed at the time of inspection, the roof is approaching the end of its useful life. The client should consult a qualified roofing contractor for further evaluation and budgeting purposes. This evaluation is based solely on visual observations without invasive testing, and no warranty is expressed or implied regarding the remaining life expectancy.

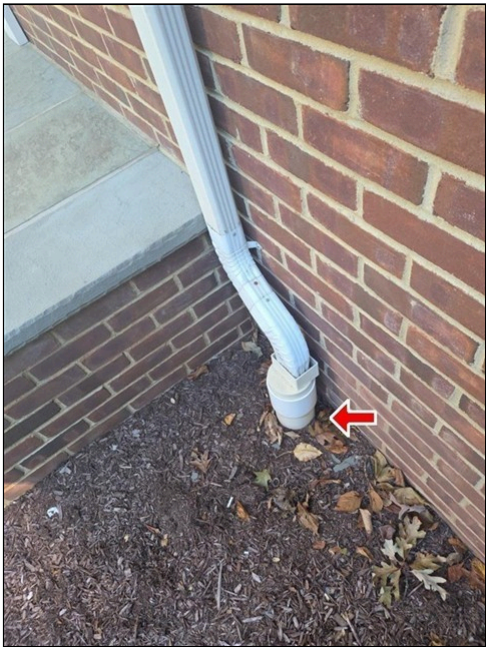
1.3 Item 1(Picture)

The downspouts terminate into an underground pipe system. I was unable to determine drainage location and if drains function properly. Recommend to verify termination points and that drains are unobstructed/ operating properly. Water should flow as far as possible from the foundation to prevent water damage.

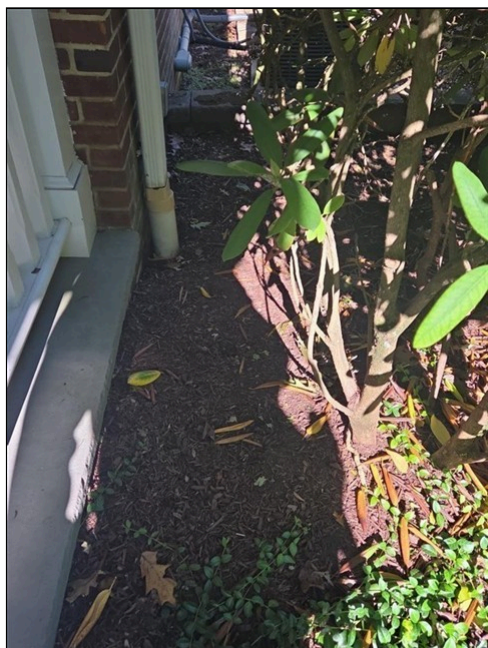
2.4 Item 1(Picture)

There is a negative slope at the exterior and can cause or contribute to water intrusion or deterioration of the foundation. Grading correction is needed by a qualified landscaping contractor prior to closing.

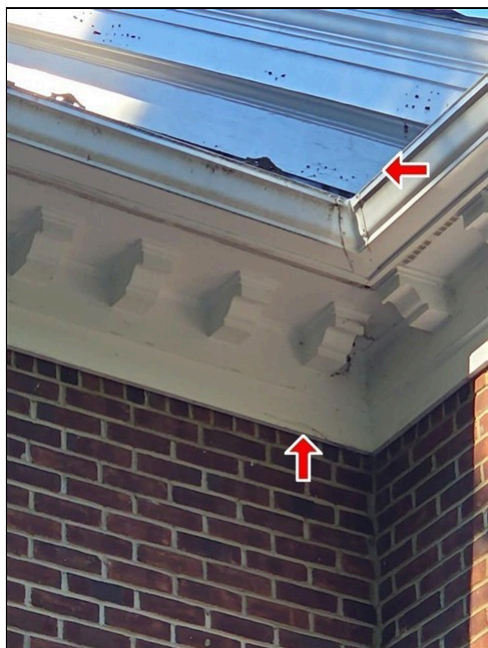
2.5 Item 1(Picture)

Soffit panel and fascia at the exterior is damaged. Further deterioration may occur if not repaired. A qualified contractor should further evaluate and make repairs prior to closing.

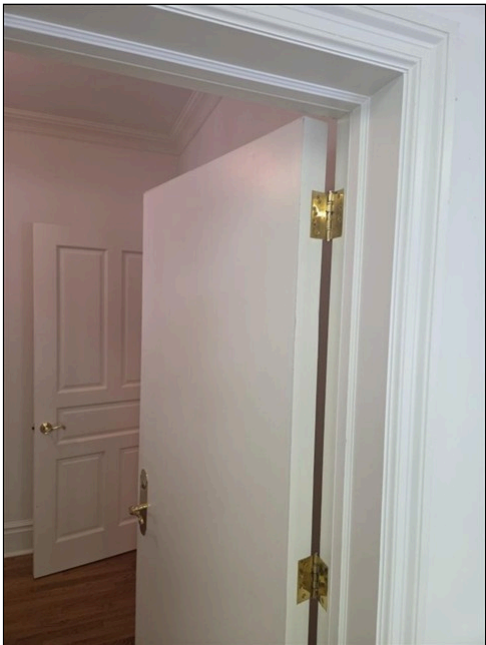
3.4 Item 1(Picture)

The occupant door from inside garage to inside the home is not a self closing, fire rated door. This means that should a fire occur in garage, the occupant door does not afford protection until fireman arrive. This door should be replaced with a fire rated door.

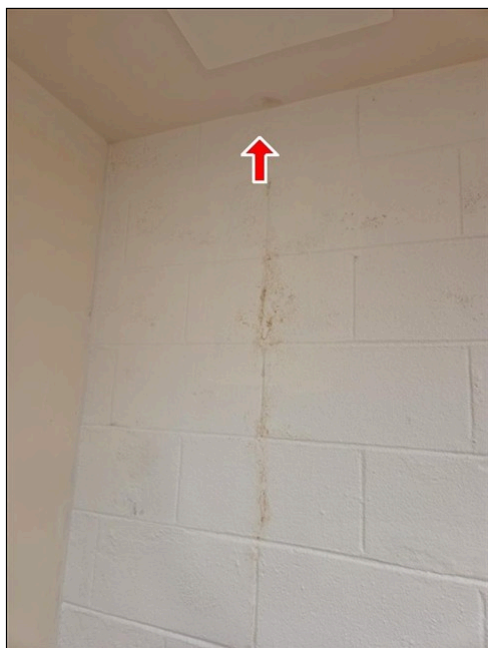
4.1 Item 1(Picture)

At the time of inspection the ceiling covering revealed a water stain indicating a leak did or still does exist. Water leaks when not repaired can lead to mold or deterioration of building components. Further evaluation by a qualified contractor is needed prior to closing to determine what repairs are needed.

Signs of fungi growth are present on ceiling in several areas. We did not inspect, test or determine if this growth is or is not a health hazard. The underlying cause is moisture or dampness. I recommend you contact a mold inspector or expert for investigation or correction if needed.

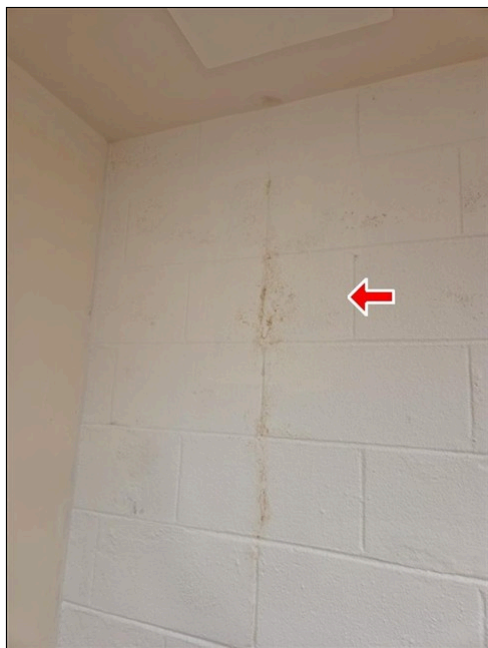
4.2 Item 1(Picture)

At the time of inspection the wall covering revealed a water stain indicating a leak did or still does exist. Water leaks when not repaired can lead to mold or deterioration of building components. Further evaluation by a qualified contractor is needed prior to closing to determine what repairs are needed.

Signs of fungi growth are present on ceiling in several areas. We did not inspect, test or determine if this growth is or is not a health hazard. The underlying cause is moisture or dampness. I recommend you contact a mold inspector or expert for investigation or correction if needed.

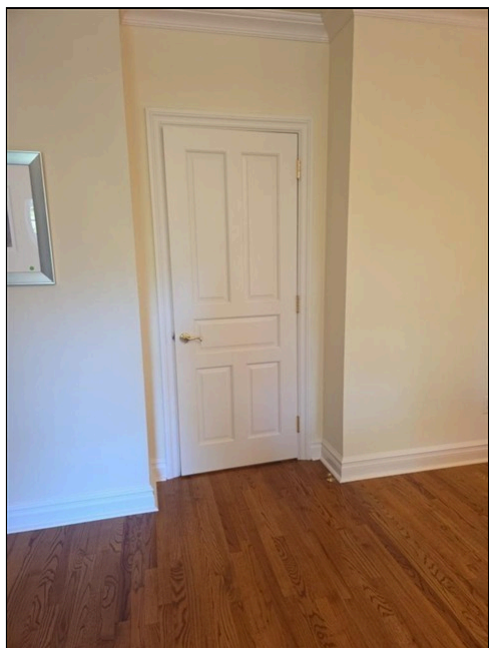
4.5 Item 1(Picture)

The interior door does not fit the opening properly. Repairs are needed to insure doors close and latch properly. A qualified carpenter should further evaluate and make needed repairs.

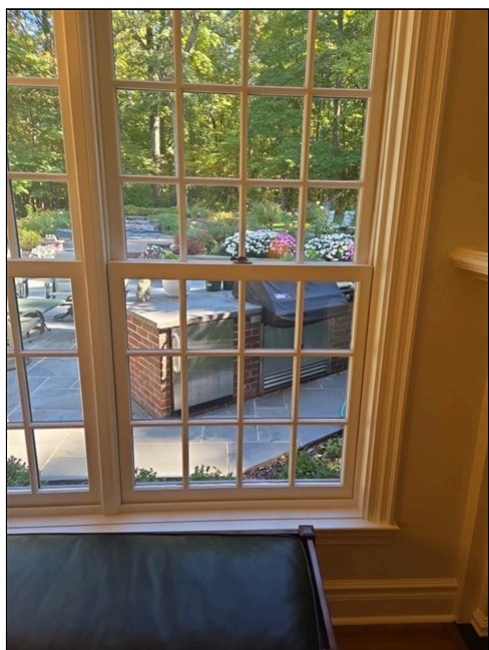
4.6 Item 1(Picture)

(1) The double hung window in the family room off of the kitchen was difficult to open and close. Further evaluation and repair/replacement is needed by a qualified contractor.

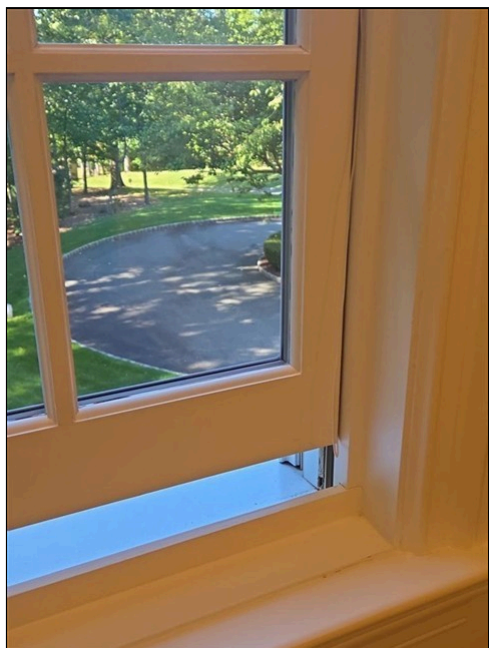
4.6 Item 2(Picture)

(2) Window sash cord is damaged. This is a safety issue as a finger/hand could be injured. A building contractor should repair or replace prior to closing.

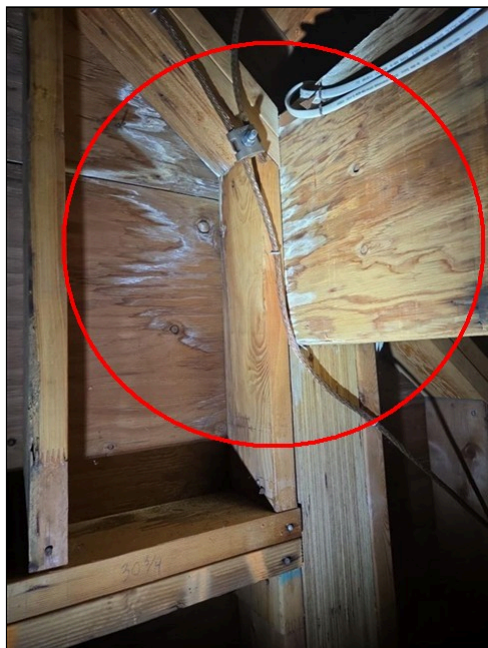
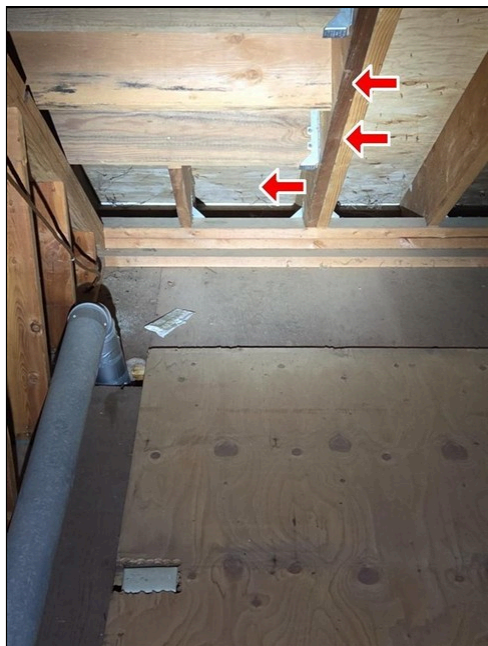
(1) The roof sheathing has fungi growth indicating moisture intrusion in areas. Signs of fungi growth indicate that moisture is entering inside the attic. The cause of moisture needs to be found and corrected. We did not inspect, test or determine if this growth is or is not a health hazard. I recommend you contact a mold inspector or expert for investigation or correction if needed.

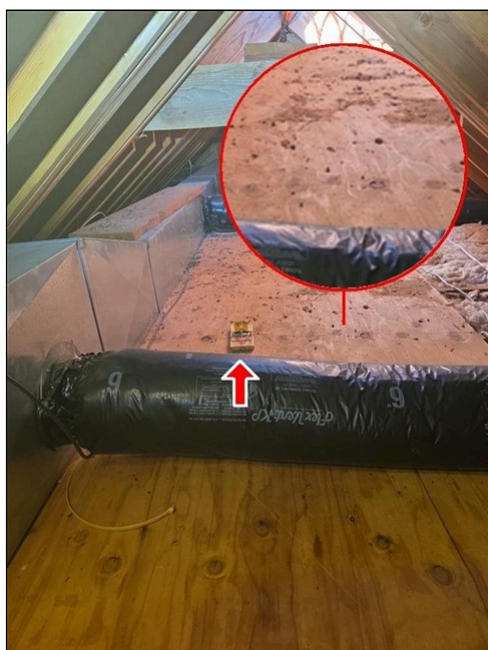
5.4 Item 4(Picture)

(2) Numerous rodent traps, including traps consistent with mouse and rat control, were observed throughout the attic. A significant amount of rodent fecal matter was also observed in multiple areas. These conditions are indicative of current and/or previous rodent activity.

The extent of the observed evidence suggests that the attic may have experienced significant rodent infestation and/or ongoing pest activity. The source of entry and the extent of any concealed damage could not be determined as part of this visual inspection.

Recommend evaluation by a qualified pest control professional to determine whether active infestation is present, identify and seal potential points of entry, and provide appropriate remediation. Following pest remediation, the attic should be cleaned and sanitized as appropriate. Any insulation or building materials contaminated or damaged by rodent activity should be evaluated for replacement.

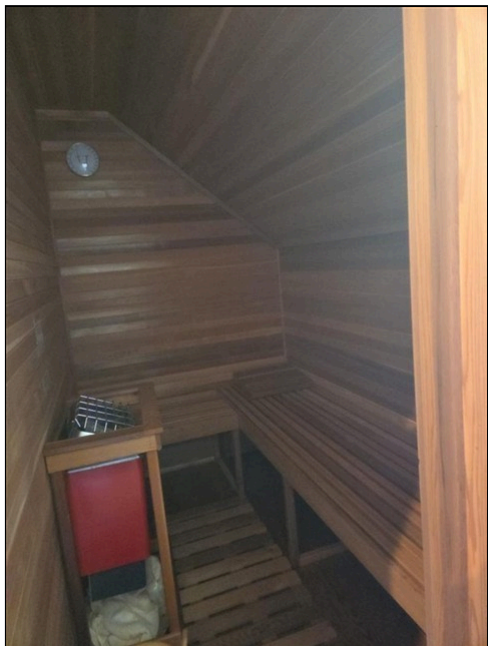
6.1 Item 1(Picture)

(1) The sauna was not inspected as part of this home inspection. The sauna was not operated or evaluated for proper function, condition, safety, or installation. Recommend evaluation by a qualified contractor familiar with sauna systems prior to closing.

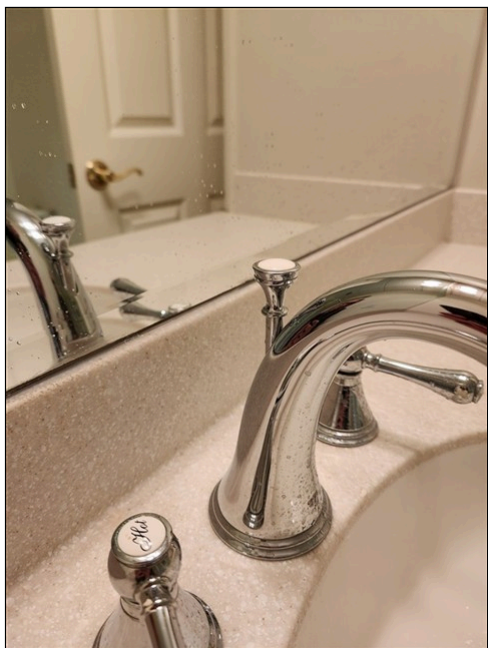
6.1 Item 2(Picture)

(2) The sink stopper/plunger at the basement bathroom sink was tested and did not function properly at the time of inspection. The stopper did not operate as intended. Recommend repair or replacement by a qualified plumbing contractor.

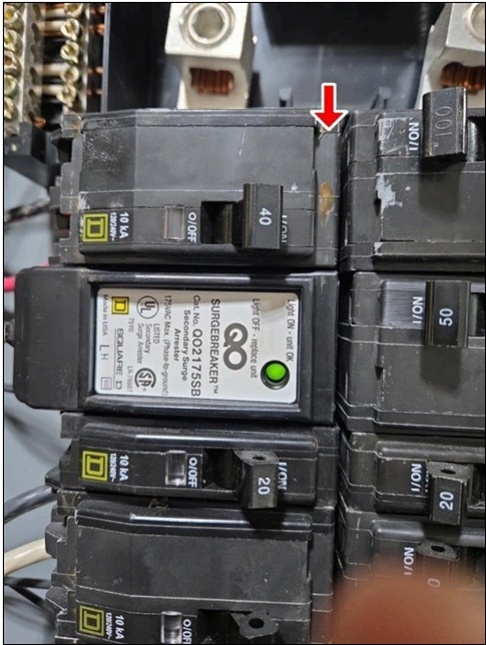
7.0 Item 1(Picture)

Rust was noted inside the main service panel (labeled panel "B" and panel "E") which is an indication of moisture intrusion. Rust can inhibit circuit breaker performance and may not allow breakers to perform as intended leading to a fire hazard. Further evaluation and repair is needed by a licensed electrician prior to closing.

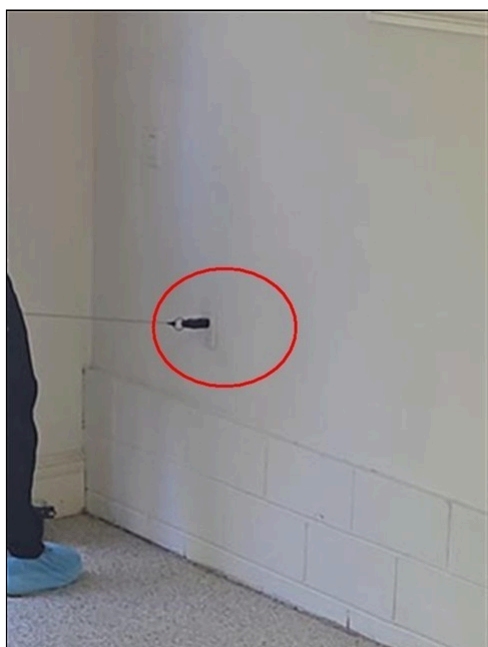
7.3 Item 1(Picture)

Several electrical receptacles were found to be without power at the time of inspection. The cause could not be determined during the inspection. Recommend evaluation by a qualified electrician to determine the cause and make repairs as necessary.

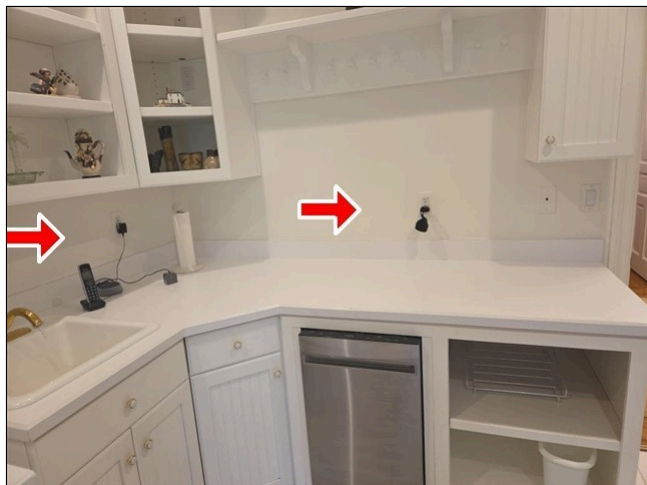
7.4 Item 1(Picture)

The laundry room counter electrical outlet is not protected by a Ground Fault Circuit Interrupter (GFCI). Current safety standards require GFCI protection for all counter outlets to reduce the risk of electric shock. Recommend evaluation and upgrade by a licensed electrician.

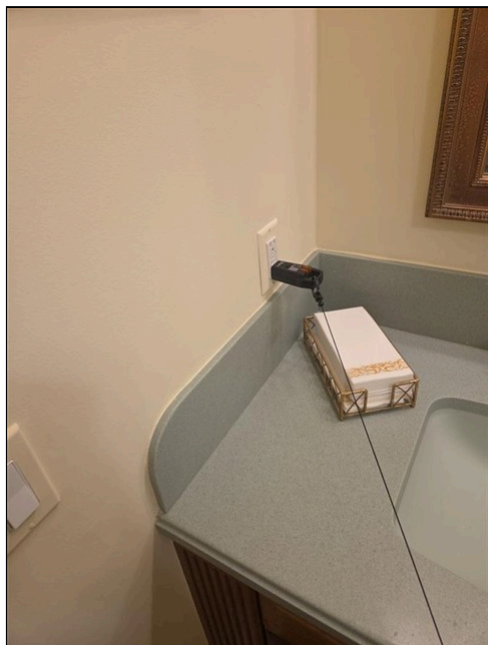
7.5 Item 1(Picture)

(1) GFCI (Ground Fault Circuit Interrupter) outlet, at the first floor bath by the wet bar area, when tripped also caused the overhead lighting to lose power. This is a safety hazard as someone could be left in the bathroom with no light in the room. Electrical issues are considered a hazard until repaired. A qualified licensed electrical contractor should perform repairs that involve wiring.

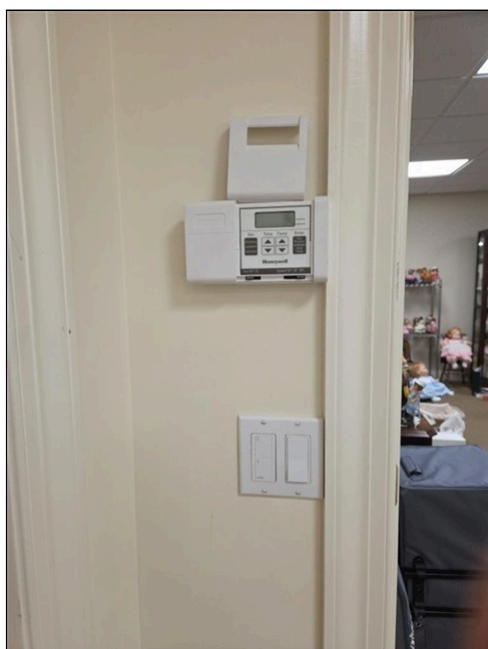
8.1 Item 1(Picture)

The basement heating system could not be operated or inspected at the time of the inspection. The thermostat was not functioning and did not respond to the controls. As a result, the operation and condition of the heating equipment could not be verified. Recommend evaluation by a qualified HVAC contractor to determine the cause of the thermostat malfunction and to inspect and test the basement heating system for proper operation and safety.

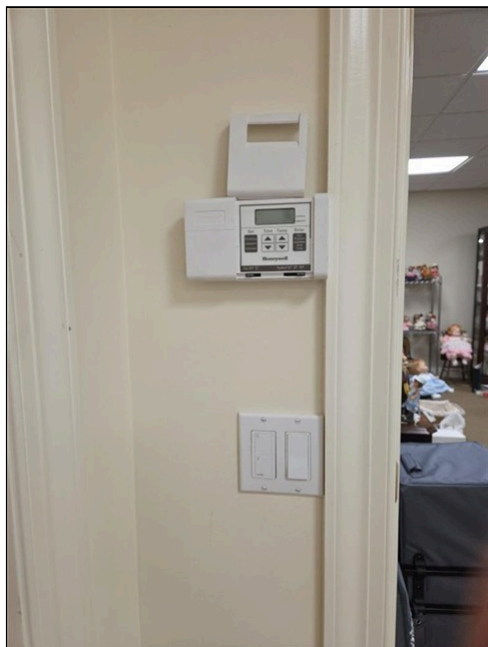
8.2 Item 1(Picture)

The basement heating system could not be operated or inspected at the time of the inspection. The thermostat was not functioning and did not respond to the controls. As a result, the operation and condition of the heating equipment could not be verified. Recommend evaluation by a qualified HVAC contractor to determine the cause of the thermostat malfunction and to inspect and test the basement heating system for proper operation and safety.

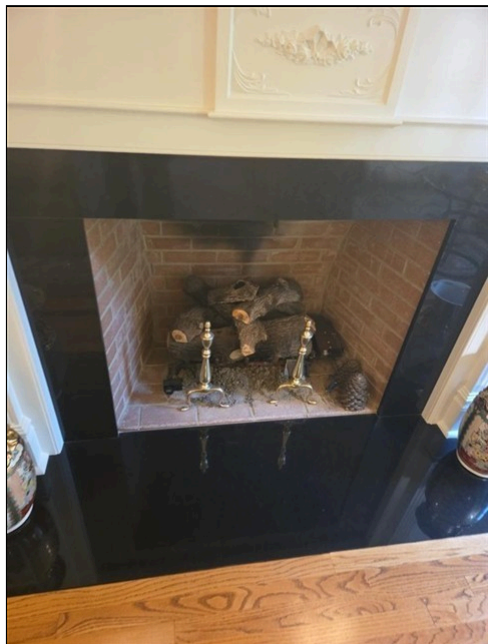
8.4 Item 1(Picture)

Gas fireplaces were present at the time of inspection; however, they could not be operated and were therefore not inspected. The condition and functionality of this appliance could not be determined. Recommend evaluation and operation by a qualified professional prior to closing.

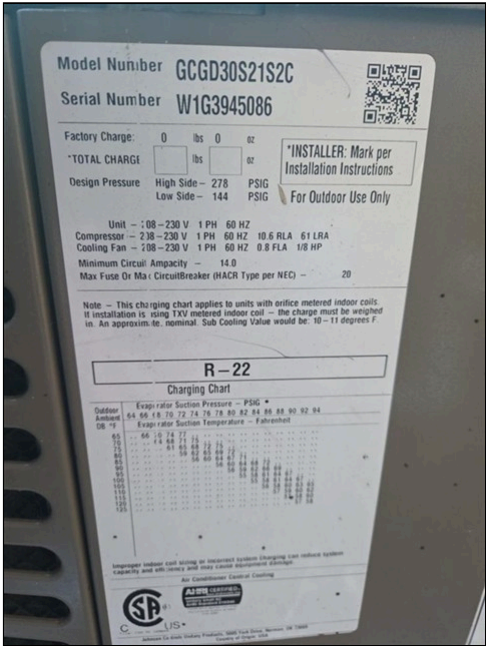
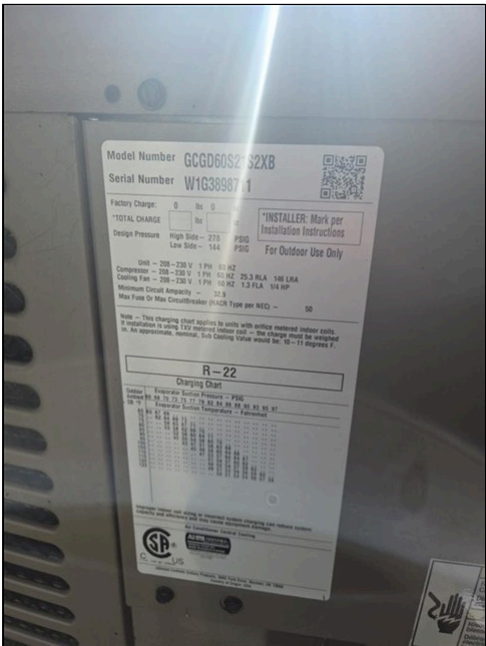
(1) All four air conditioning systems observed at the time of inspection appear to use R-22 refrigerant, which is an older refrigerant no longer manufactured or imported in the United States as of January 1, 2020, due to its harmful environmental effects. It is important to note that systems using R-22 are becoming increasingly expensive and difficult to service due to the limited availability of the refrigerant. While the system may be operational, replacement or modification may be required in the near future. Evaluation by a licensed HVAC technician is recommended to discuss repair options or system upgrade.

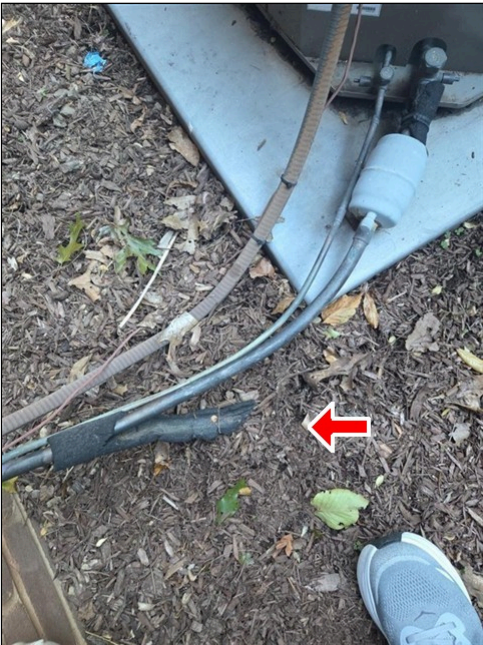
8.5 Item 7(Picture)

(2) The foam sleeves on suction lines have missing/damaged and deteriorated foam sleeves at outside units. Missing/damaged foam on suction line can cause energy loss and condensation. I recommend service or repair as needed.

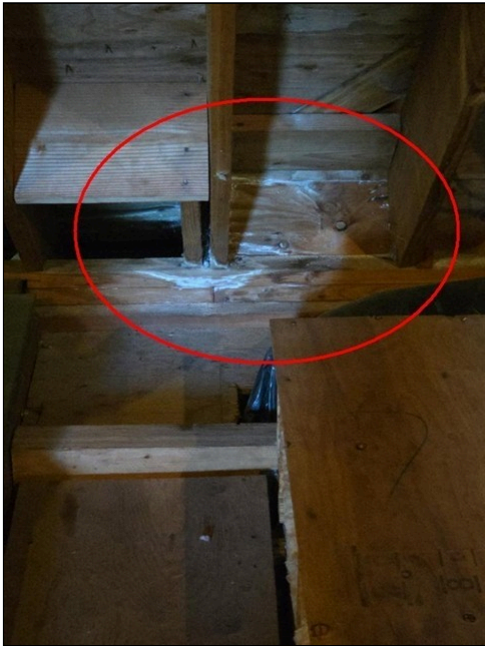
9.3 Item 1(Picture)

During the inspection of the attic, ventilation appeared to be inadequate, and what may be microbial growth (possible mold) was observed on visible wood surfaces. Poor attic ventilation can trap moisture-laden air leading to condensation and creating conditions conducive to mold or mildew growth. The apparent microbial growth should be evaluated by a qualified environmental specialist, and the attic ventilation system should be reviewed by a qualified contractor to ensure it provides adequate airflow to prevent moisture buildup.

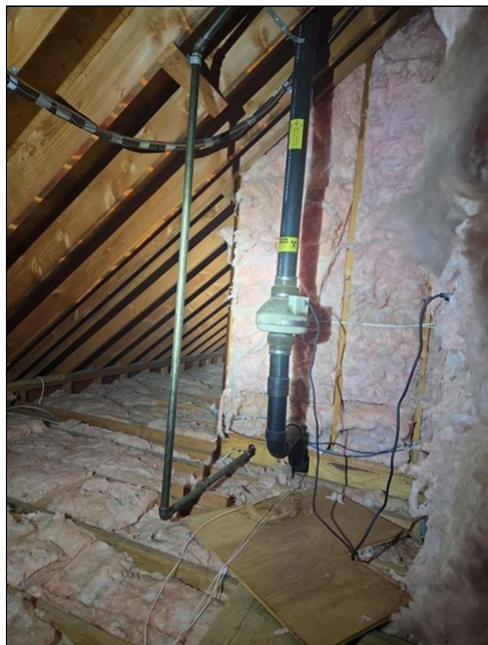
9.6 Item 1(Picture)

Two radon mitigation systems were observed at the property. The systems were not inspected or evaluated as part of this home inspection, as testing or evaluation of radon mitigation systems is outside the scope of this inspection. Recommend having both radon mitigation systems inspected and evaluated by a qualified radon mitigation professional to verify proper installation, operation, and performance. Radon testing was performed, and laboratory results will follow.

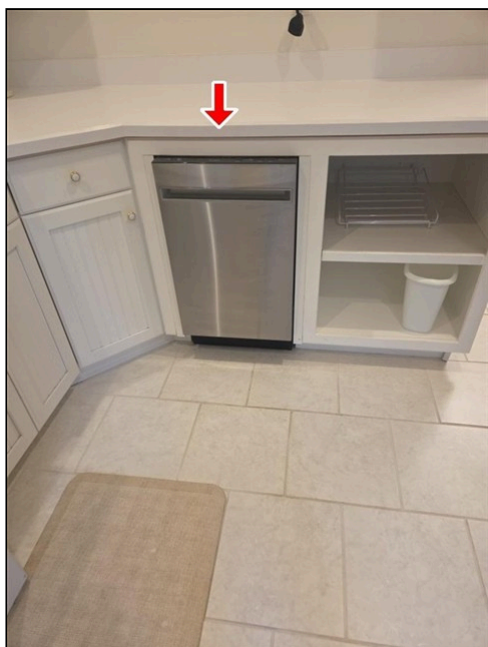
10.0 Item 1(Picture)

The laundry room unit failed to start or complete a cycle during the inspection. It is recommended that the appliance be further evaluated and repaired by a qualified technician.

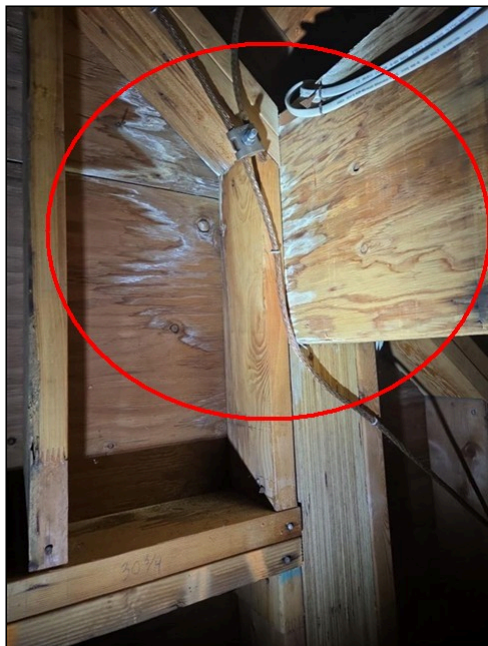
13.0 Item 1(Picture)

Further evaluation and/or remediation is recommended by a qualified and licensed mold assessor or remediation contractor.

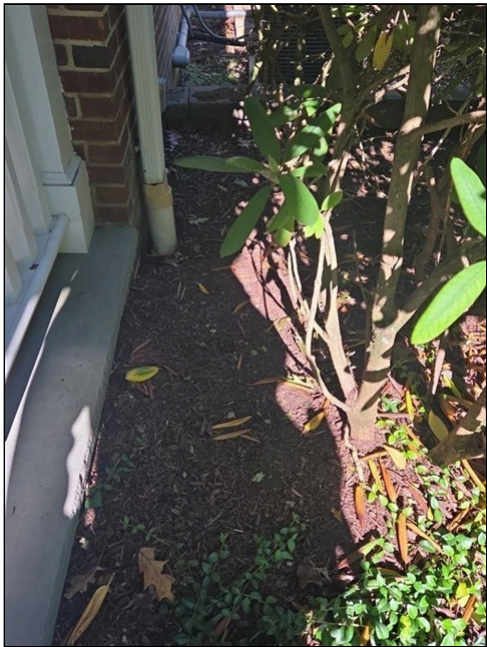
2.4 Item 1(Picture)

There is a negative slope at the exterior and can cause or contribute to water intrusion or deterioration of the foundation. Grading correction is needed by a qualified landscaping contractor prior to closing.

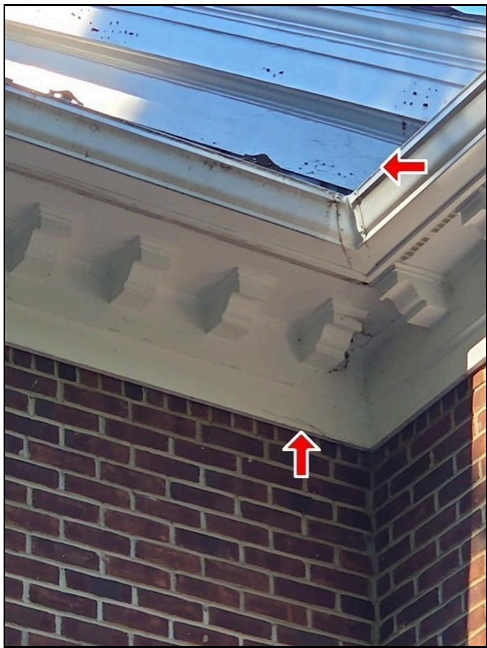
2.5 Item 1(Picture)

Soffit panel and fascia at the exterior is damaged. Further deterioration may occur if not repaired. A qualified contractor should further evaluate and make repairs prior to closing.

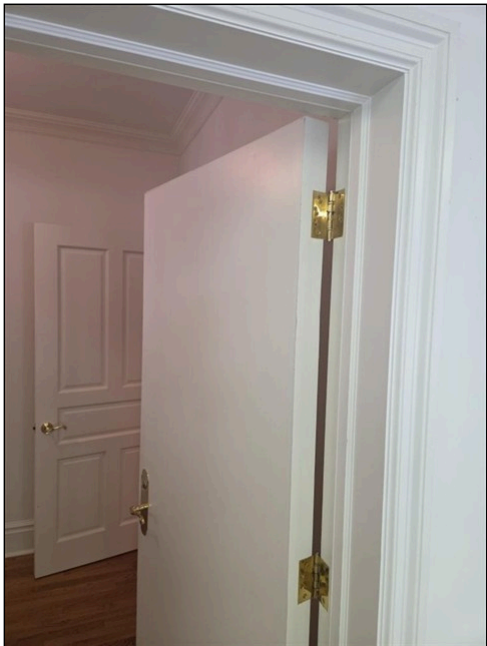
3.4 Item 1(Picture)

The occupant door from inside garage to inside the home is not a self closing, fire rated door. This means that should a fire occur in garage, the occupant door does not afford protection until fireman arrive. This door should be replaced with a fire rated door.

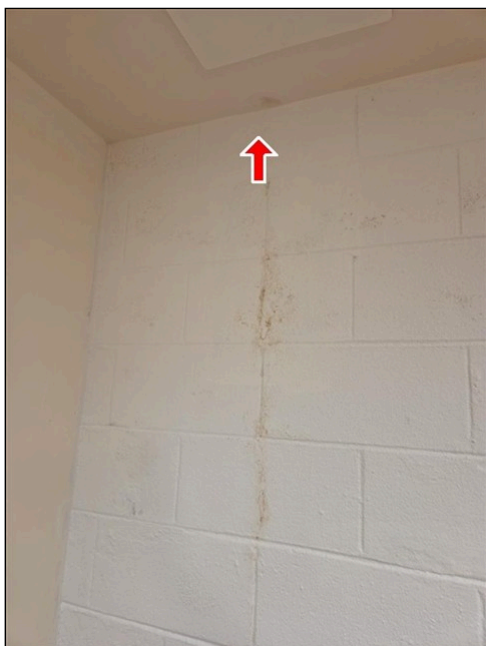
4.1 Item 1(Picture)

Signs of fungi growth are present on ceiling in several areas. We did not inspect, test or determine if this growth is or is not a health hazard. The underlying cause is moisture or dampness. I recommend you contact a mold inspector or expert for investigation or correction if needed.

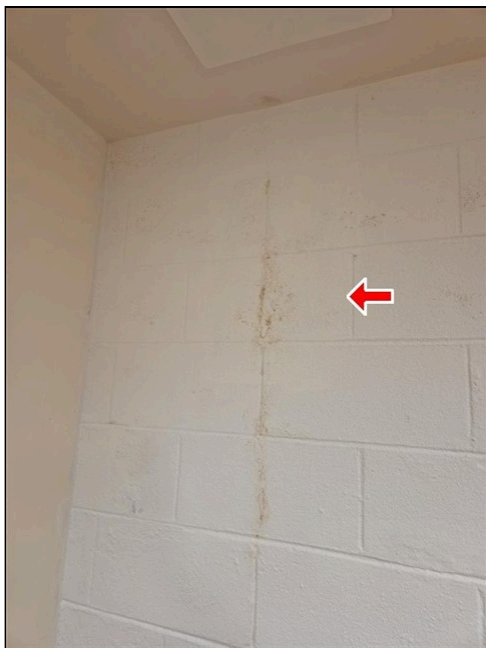
4.2 Item 1(Picture)

Signs of fungi growth are present on ceiling in several areas. We did not inspect, test or determine if this growth is or is not a health hazard. The underlying cause is moisture or dampness. I recommend you contact a mold inspector or expert for investigation or correction if needed.

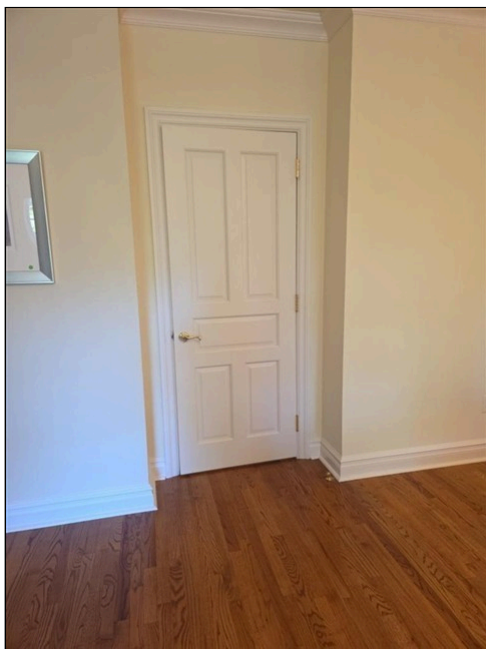
4.5 Item 1(Picture)

The interior door does not fit the opening properly. Repairs are needed to insure doors close and latch properly. A qualified carpenter should further evaluate and make needed repairs.

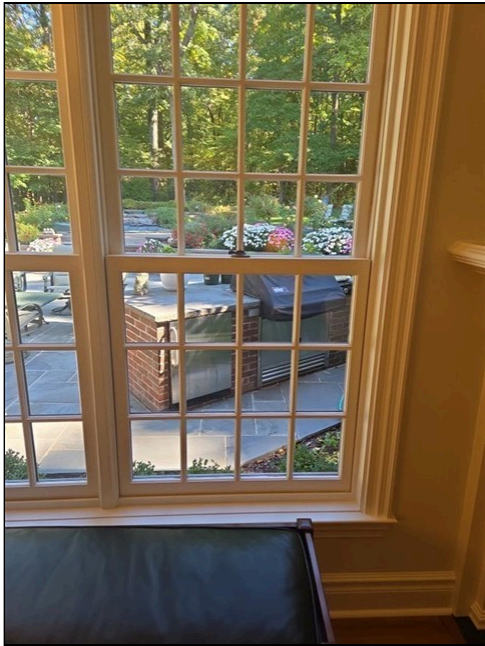
4.6 Item 1(Picture)

(1) The double hung window in the family room off of the kitchen was difficult to open and close. Further evaluation and repair/replacement is needed by a qualified contractor.

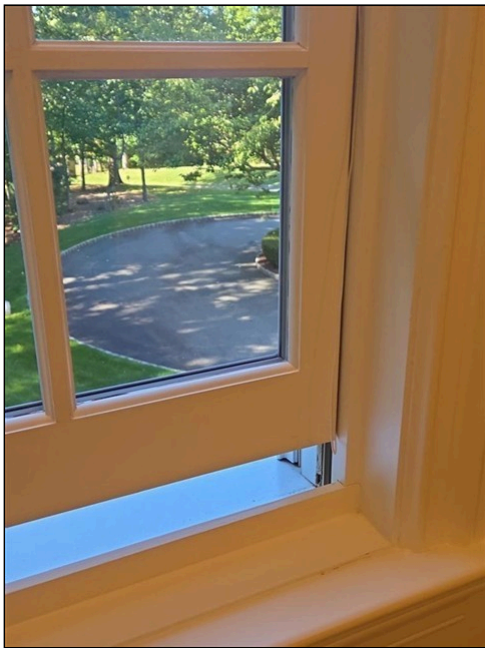
4.6 Item 2(Picture)

(2) Window sash cord is damaged. This is a safety issue as a finger/hand could be injured. A building contractor should repair or replace prior to closing.

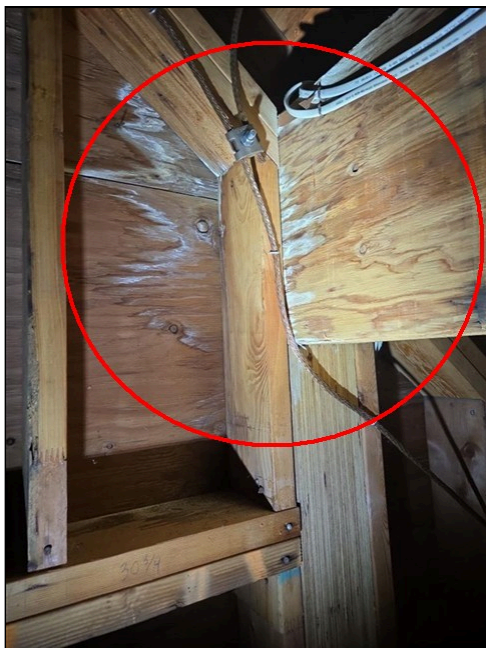
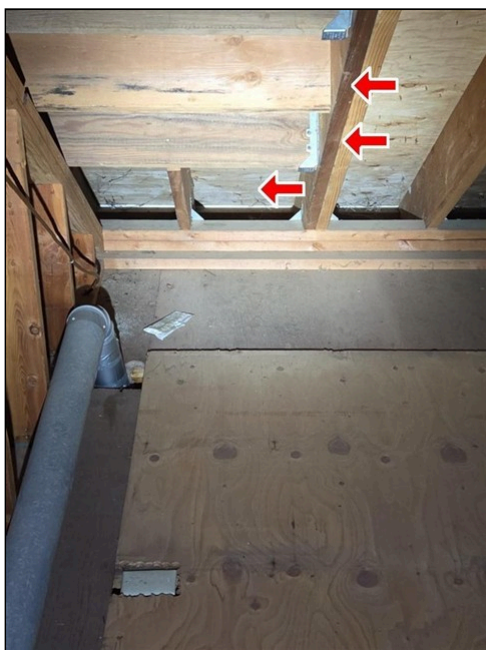
(1) The roof sheathing has fungi growth indicating moisture intrusion in areas. Signs of fungi growth indicate that moisture is entering inside the attic. The cause of moisture needs to be found and corrected. We did not inspect, test or determine if this growth is or is not a health hazard. I recommend you contact a mold inspector or expert for investigation or correction if needed.

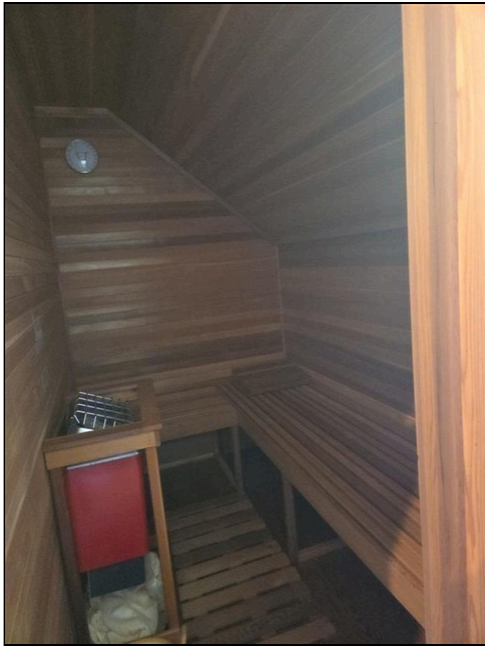
6.1 Item 1(Picture)

(1) The sauna was not inspected as part of this home inspection. The sauna was not operated or evaluated for proper function, condition, safety, or installation. Recommend evaluation by a qualified contractor familiar with sauna systems prior to closing.

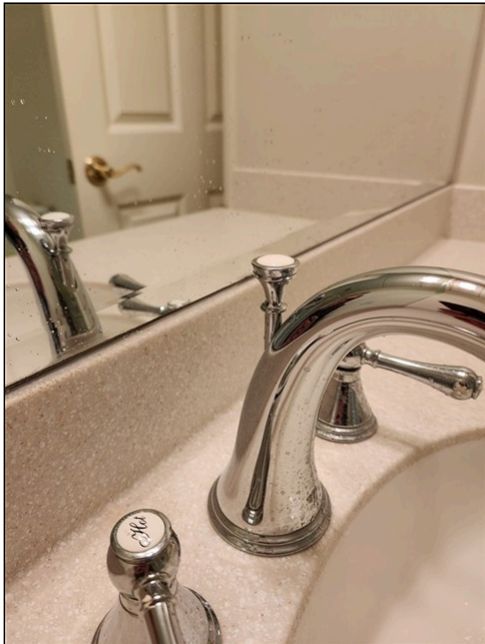
6.1 Item 2(Picture)

(2) The sink stopper/plunger at the basement bathroom sink was tested and did not function properly at the time of inspection. The stopper did not operate as intended. Recommend repair or replacement by a qualified plumbing contractor.

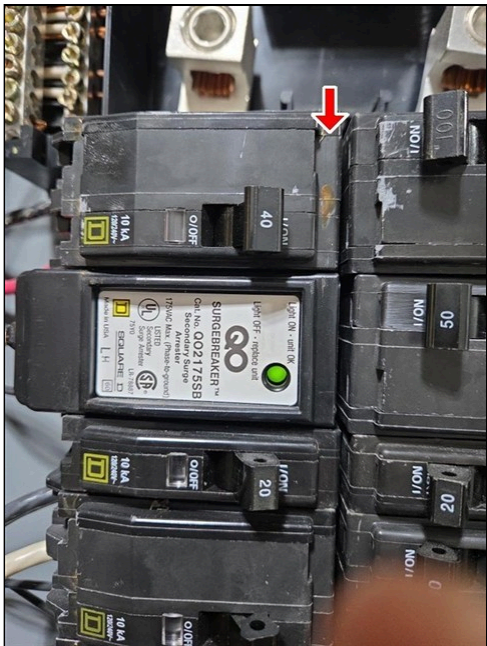
7.0 Item 1(Picture)

Rust was noted inside the main service panel (labeled panel "B" and panel "E") which is an indication of moisture intrusion. Rust can inhibit circuit breaker performance and may not allow breakers to perform as intended leading to a fire hazard. Further evaluation and repair is needed by a licensed electrician prior to closing.

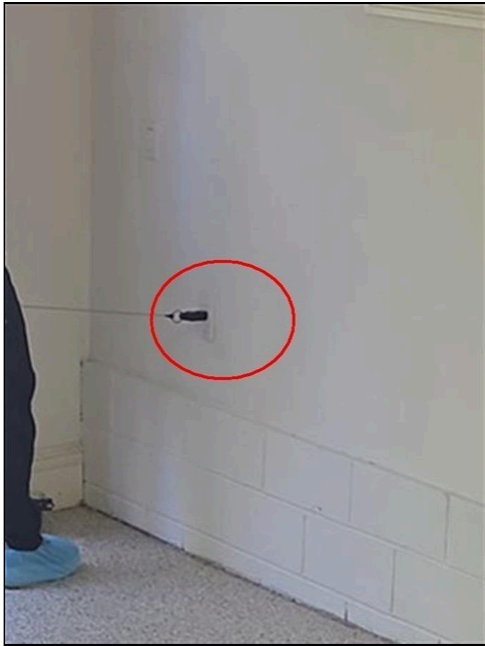
7.3 Item 1(Picture)

Several electrical receptacles were found to be without power at the time of inspection. The cause could not be determined during the inspection. Recommend evaluation by a qualified electrician to determine the cause and make repairs as necessary.

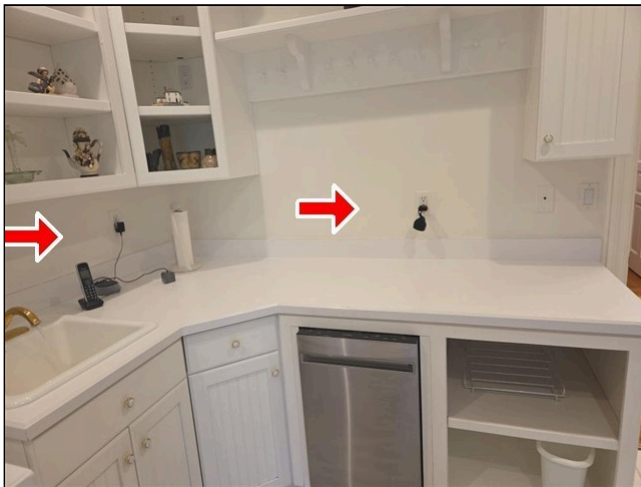
7.4 Item 1(Picture)

The laundry room counter electrical outlet is not protected by a Ground Fault Circuit Interrupter (GFCI). Current safety standards require GFCI protection for all counter outlets to reduce the risk of electric shock. Recommend evaluation and upgrade by a licensed electrician.

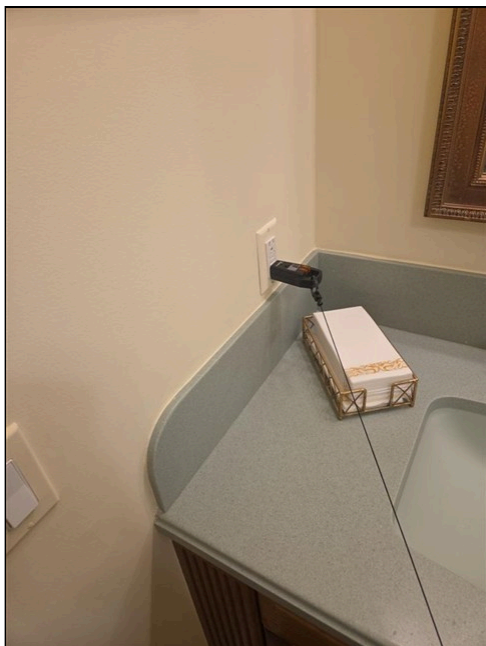
7.5 Item 1(Picture)

(1) GFCI (Ground Fault Circuit Interrupter) outlet, at the first floor bath by the wet bar area, when tripped also caused the overhead lighting to lose power. This is a safety hazard as someone could be left in the bathroom with no light in the room. Electrical issues are considered a hazard until repaired. A qualified licensed electrical contractor should perform repairs that involve wiring.

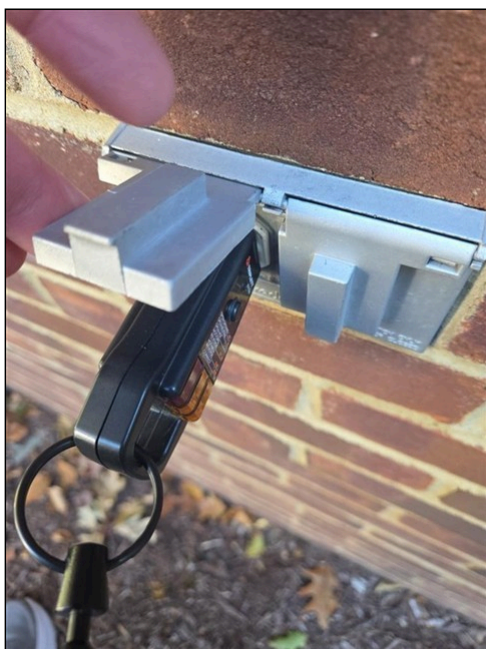
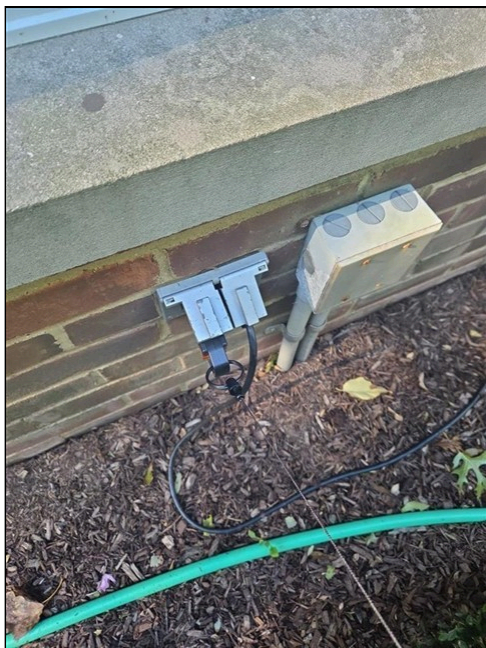
(2) Several exterior electrical receptacles were tested and found to have no power at the time of inspection. The cause could not be determined during the inspection. Recommend evaluation by a qualified electrician to determine the cause and restore proper operation. Any exterior receptacles should be properly protected with GFCI protection and weather-resistant covers as applicable.

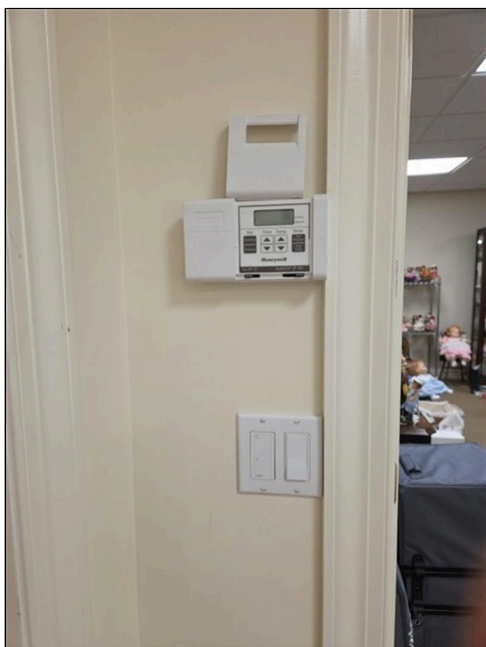
8.1 Item 1(Picture)

The basement heating system could not be operated or inspected at the time of the inspection. The thermostat was not functioning and did not respond to the controls. As a result, the operation and condition of the heating equipment could not be verified. Recommend evaluation by a qualified HVAC contractor to determine the cause of the thermostat malfunction and to inspect and test the basement heating system for proper operation and safety.
