# Inspection Report

100 My Dream House Lane  
City of Dreams NJ 99999

**Safeway Home Inspections**

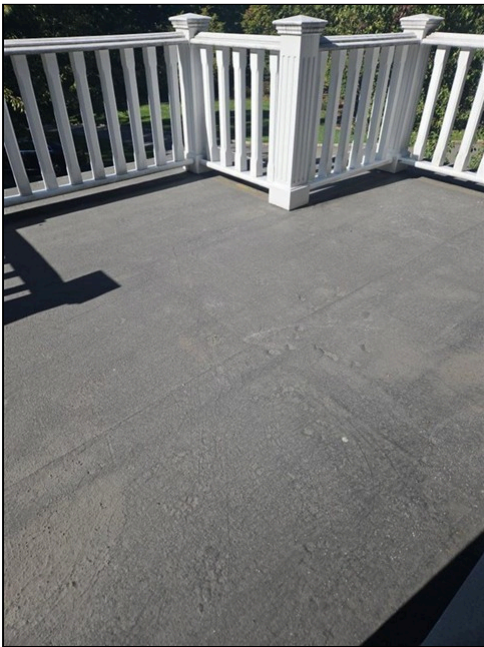
1.0 Item 2(Picture)

The flat roof covering appears to be older and showing signs of ageing such as granule loss and general weathering. While no immediate failures were observed at the time of inspection, the roof is approaching the end of its useful life. The client should consult a qualified roofing contractor for further evaluation and budgeting purposes. This evaluation is based solely on visual observations without invasive testing, and no warranty is expressed or implied regarding the remaining life expectancy.

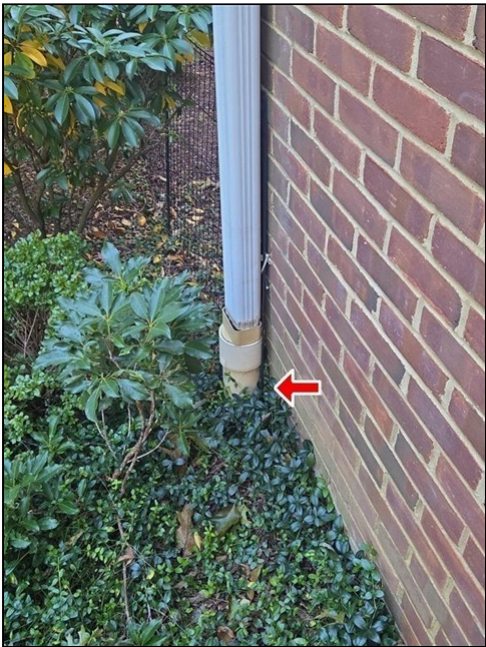
1.3 Item 2(Picture)

The downspouts terminate into an underground pipe system. I was unable to determine drainage location and if drains function properly. Recommend to verify termination points and that drains are unobstructed/ operating properly. Water should flow as far as possible from the foundation to prevent water damage.

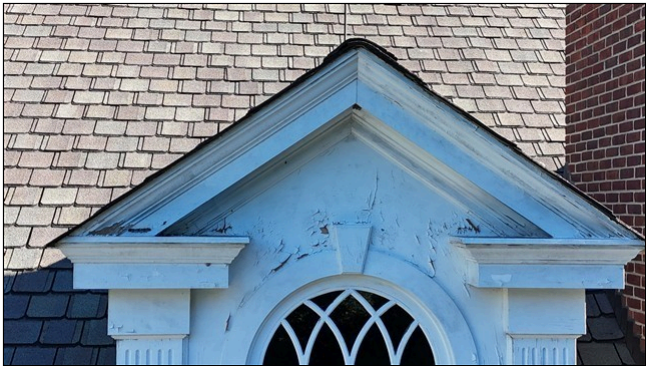
2.0 Item 1(Picture)

The siding has peeling paint at various locations. Further deterioration may occur if not repaired. I recommend a qualified contractor inspect and repair as needed.

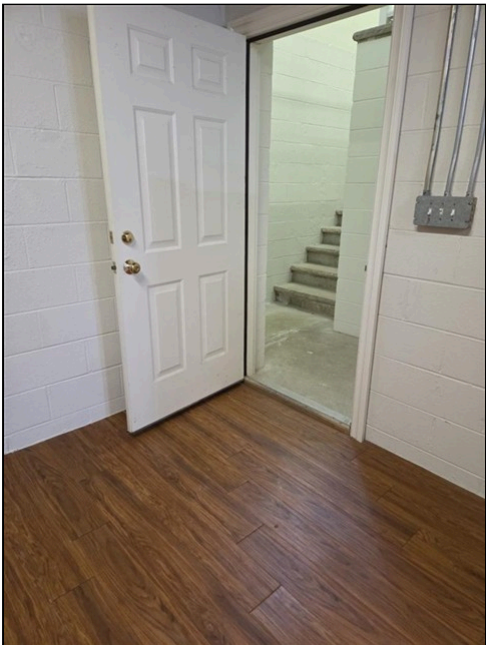
3.4 Item 2(Picture)

The occupant door from inside garage to inside the home is not a self closing, fire rated door. This means that should a fire occur in garage, the occupant door does not afford protection until fireman arrive. This door should be replaced with a fire rated door.

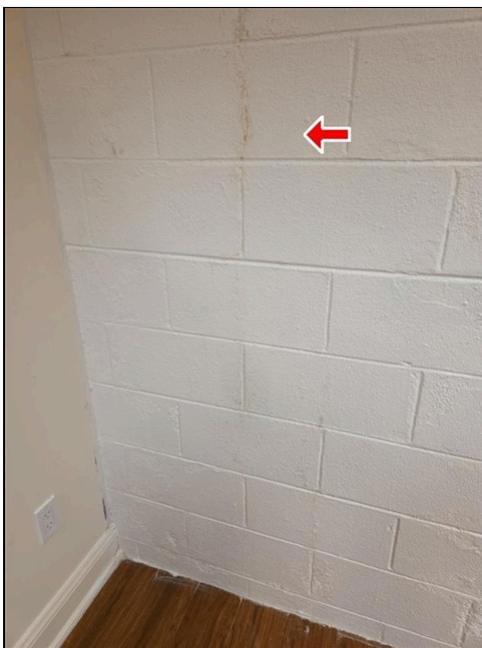
4.2 Item 2(Picture)

At the time of inspection the wall covering revealed a water stain indicating a leak did or still does exist. Water leaks when not repaired can lead to mold or deterioration of building components. Further evaluation by a qualified contractor is needed prior to closing to determine what repairs are needed.

Signs of fungi growth are present on ceiling in several areas. We did not inspect, test or determine if this growth is or is not a health hazard. The underlying cause is moisture or dampness. I recommend you contact a mold inspector or expert for investigation or correction if needed.

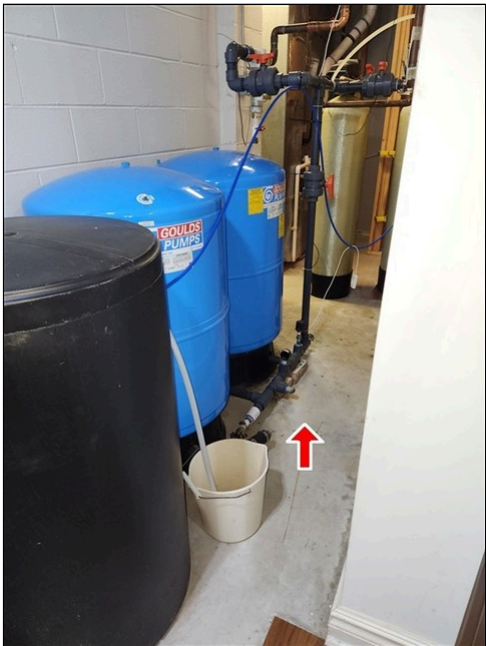
6.3 Item 1(Picture)

The main water shut off is the knob located in the basement. This for your information.

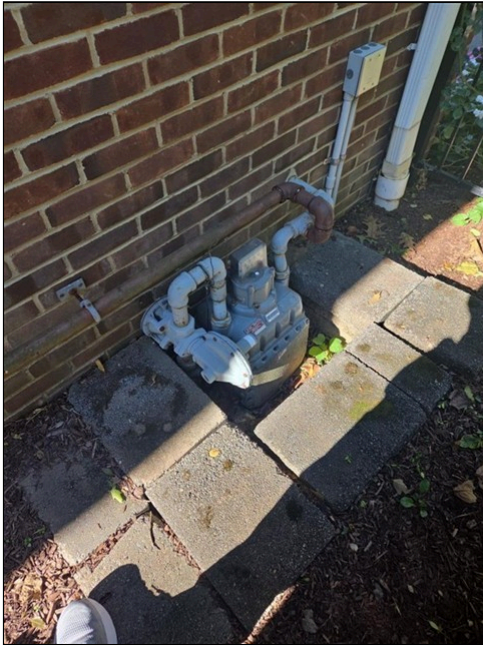
6.5 Item 1(Picture)

The main fuel shut off is at gas meter outside

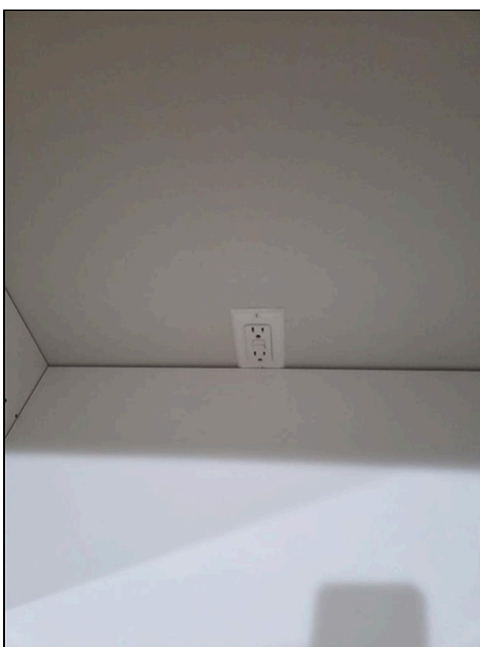
7.3 Item 2(Picture)

Several electrical receptacles were found to be without power at the time of inspection. The cause could not be determined during the inspection. Recommend evaluation by a qualified electrician to determine the cause and make repairs as necessary.

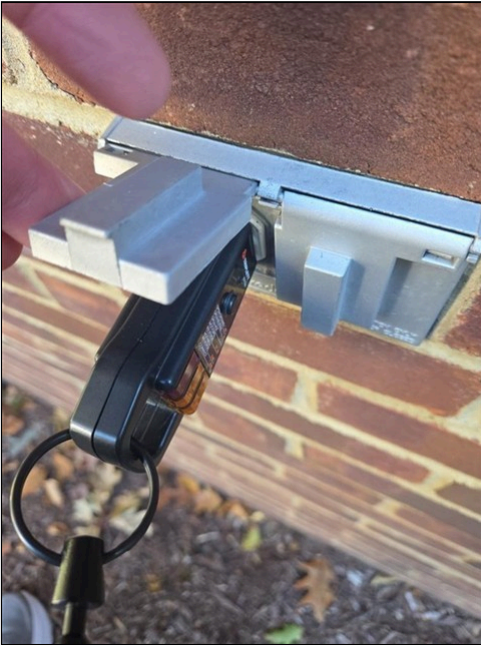
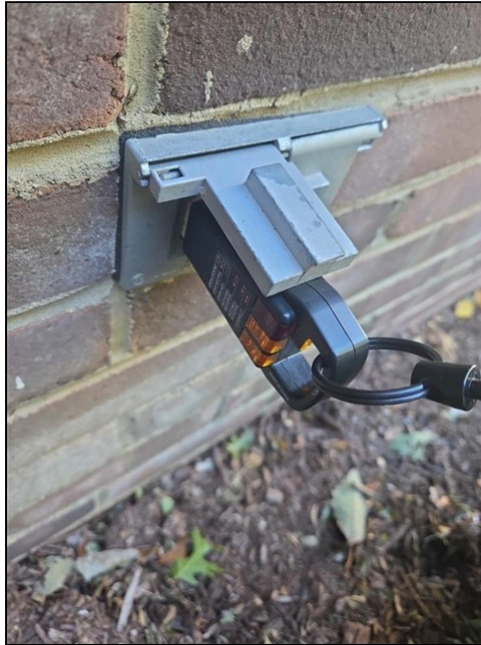
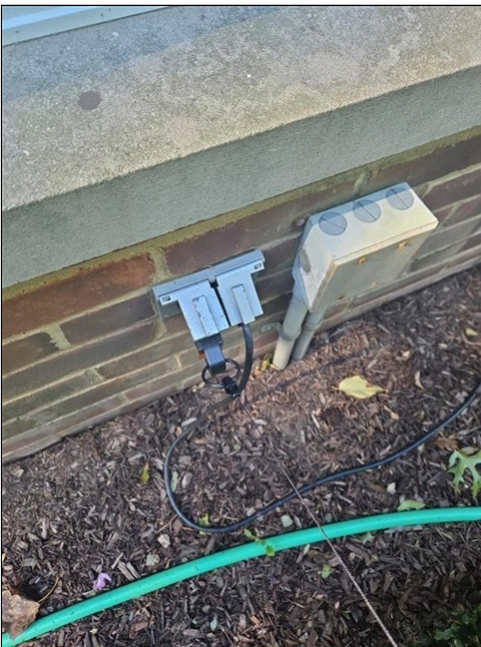
(2) Several exterior electrical receptacles were tested and found to have no power at the time of inspection. The cause could not be determined during the inspection. Recommend evaluation by a qualified electrician to determine the cause and restore proper operation. Any exterior receptacles should be properly protected with GFCI protection and weather-resistant covers as applicable.

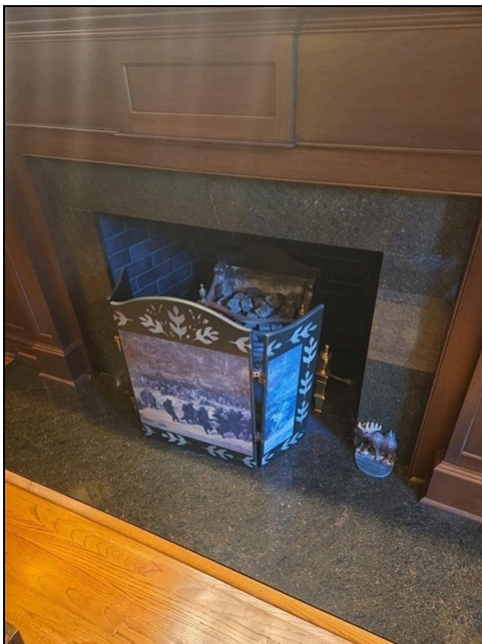
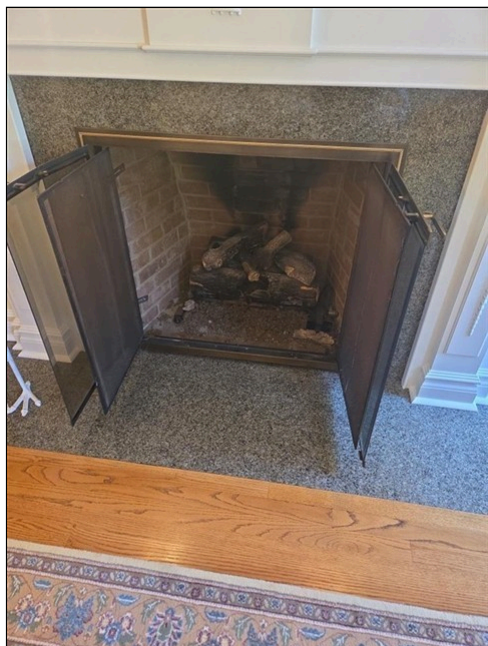
Gas fireplaces were present at the time of inspection; however, they could not be operated and were therefore not inspected. The condition and functionality of this appliance could not be determined. Recommend evaluation and operation by a qualified professional prior to closing.

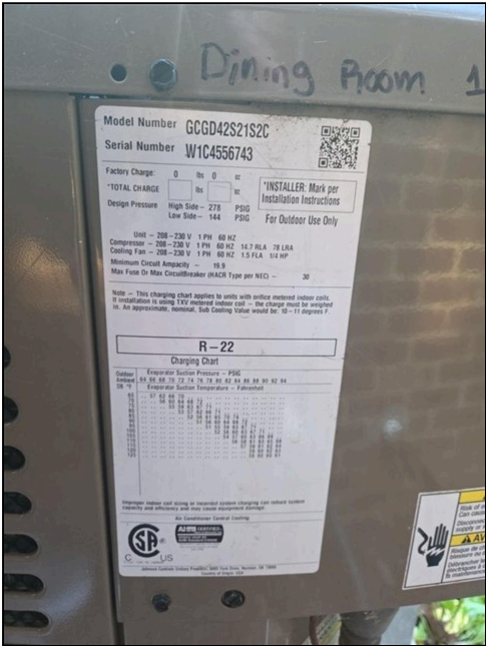
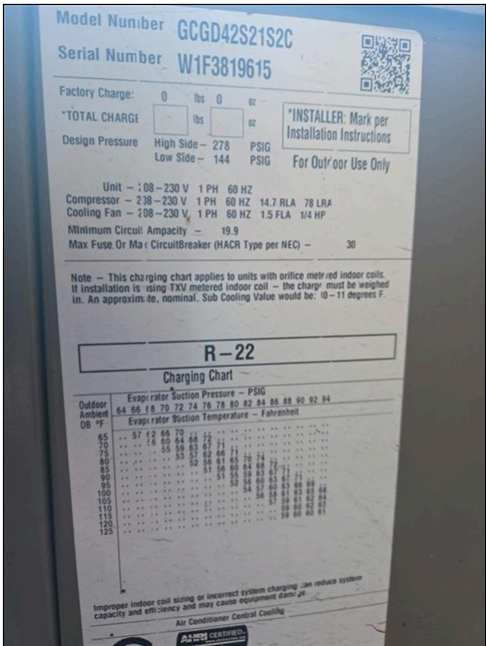
(1) All four air conditioning systems observed at the time of inspection appear to use R-22 refrigerant, which is an older refrigerant no longer manufactured or imported in the United States as of January 1, 2020, due to its harmful environmental effects. It is important to note that systems using R-22 are becoming increasingly expensive and difficult to service due to the limited availability of the refrigerant. While the system may be operational, replacement or modification may be required in the near future. Evaluation by a licensed HVAC technician is recommended to discuss repair options or system upgrade.

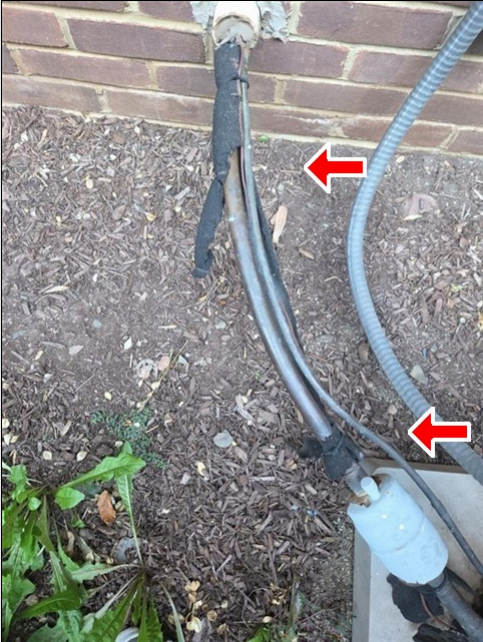
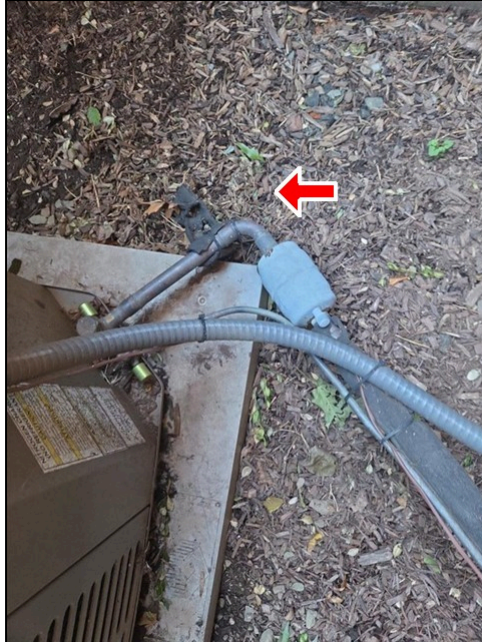
(2) The foam sleeves on suction lines have missing/damaged and deteriorated foam sleeves at outside units. Missing/damaged foam on suction line can cause energy loss and condensation. I recommend service or repair as needed.

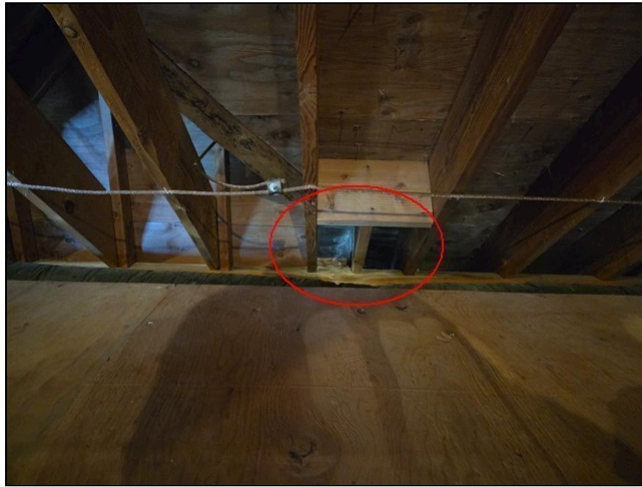
9.3 Item 2(Picture)

During the inspection of the attic, ventilation appeared to be inadequate, and what may be microbial growth (possible mold) was observed on visible wood surfaces. Poor attic ventilation can trap moisture-laden air leading to condensation and creating conditions conducive to mold or mildew growth. The apparent microbial growth should be evaluated by a qualified environmental specialist, and the attic ventilation system should be reviewed by a qualified contractor to ensure it provides adequate airflow to prevent moisture buildup.

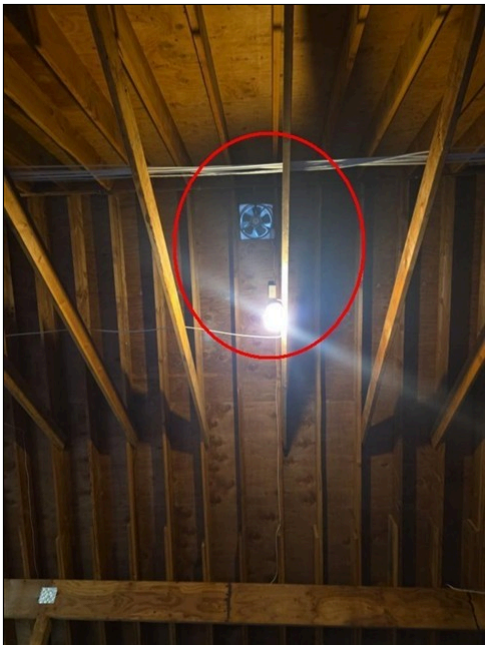
9.5 Item 1(Picture)

Thermostatically controlled ventilation fan in attic was not tested as the temperature was below that at which it would normally activate.

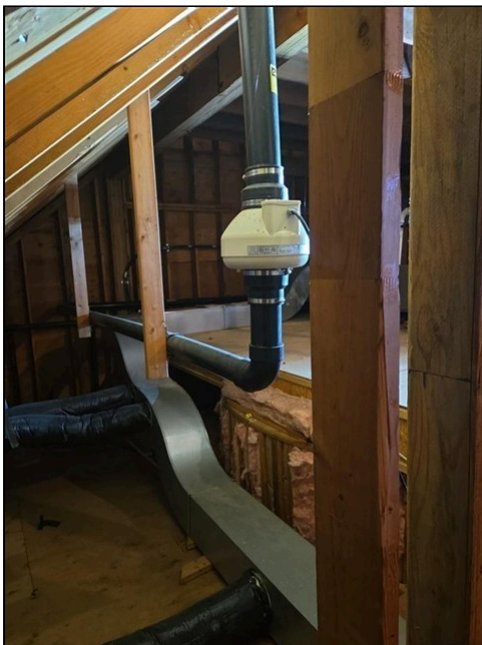
9.6 Item 2(Picture)

Two radon mitigation systems were observed at the property. The systems were not inspected or evaluated as part of this home inspection, as testing or evaluation of radon mitigation systems is outside the scope of this inspection. Recommend having both radon mitigation systems inspected and evaluated by a qualified radon mitigation professional to verify proper installation, operation, and performance. Radon testing was performed, and laboratory results will follow.

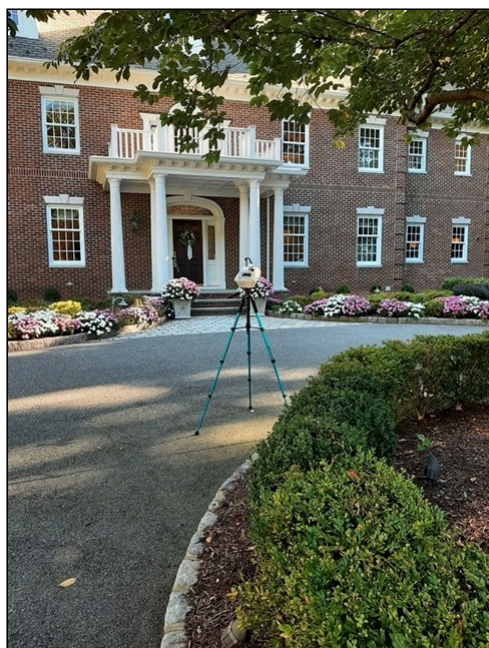
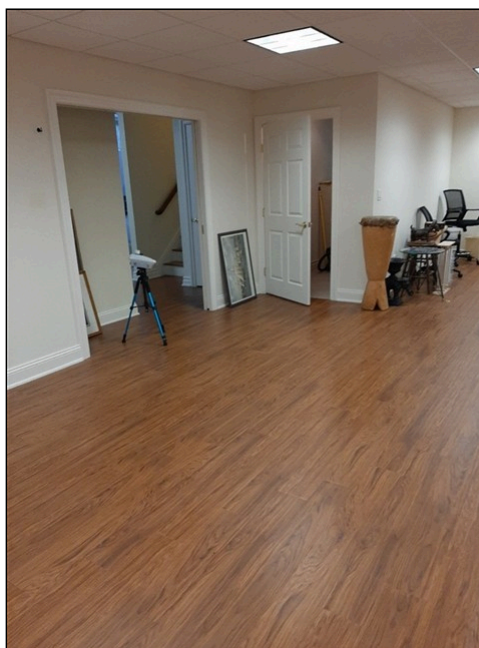
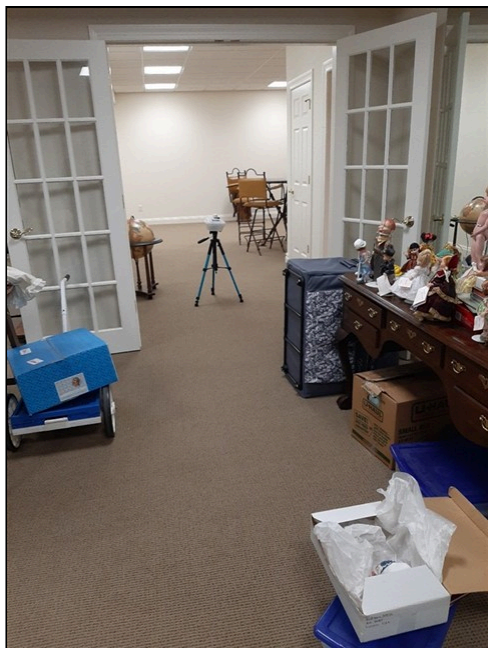
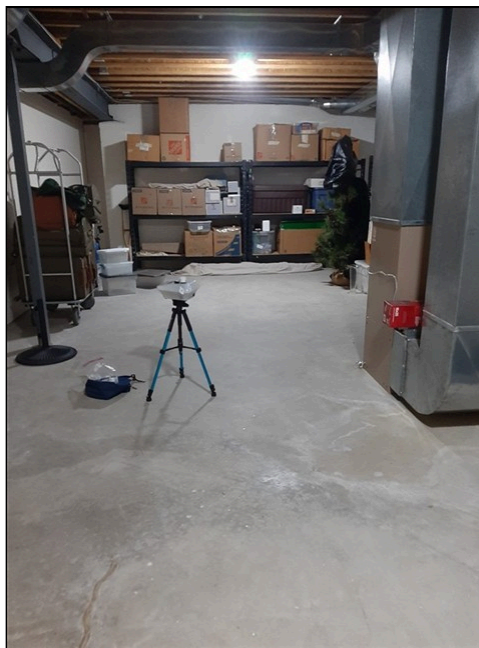
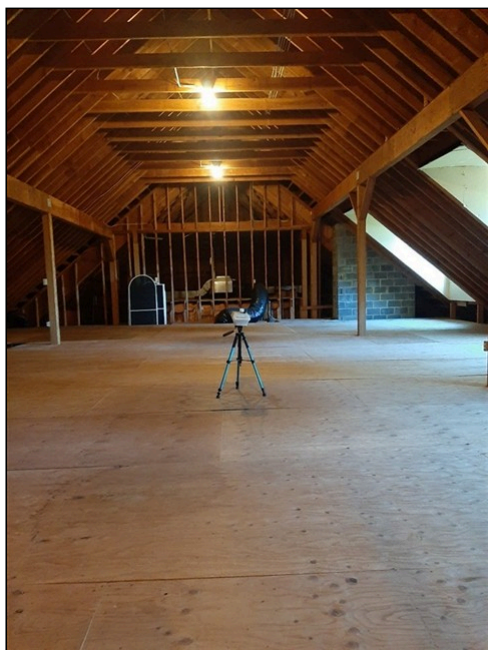
While the results are considered normal, maintaining proper moisture control, ventilation, and routine property maintenance is recommended to help prevent mold growth.

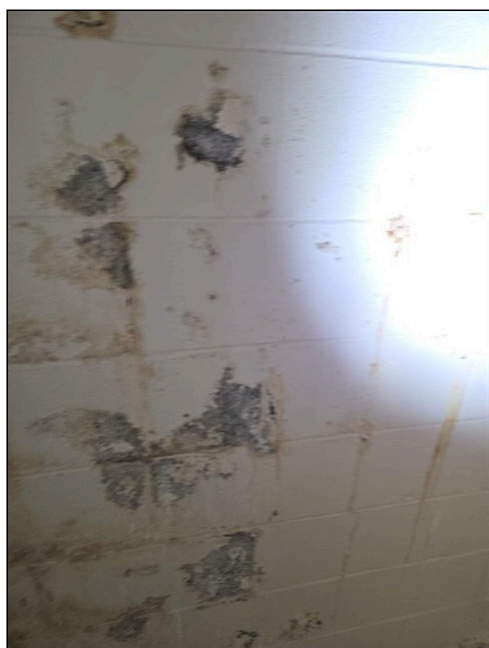
13.2 Item 1(Picture)

Based on these findings, further evaluation by a qualified licensed mold remediation professional is recommended to determine the extent of contamination and to develop an appropriate remediation plan. Correction of any underlying moisture sources is essential to prevent recurrence.

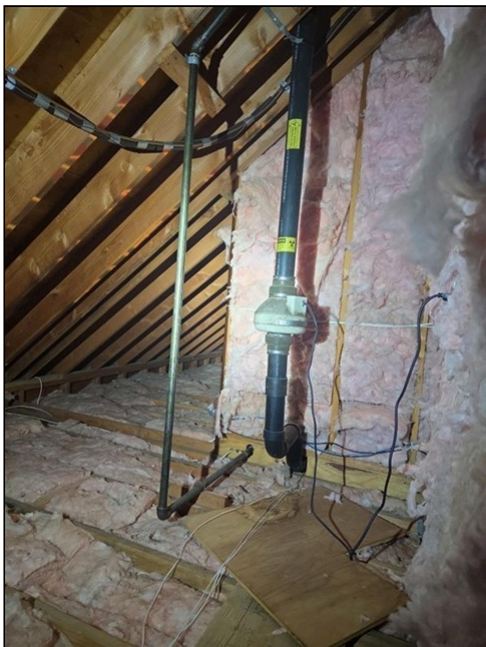
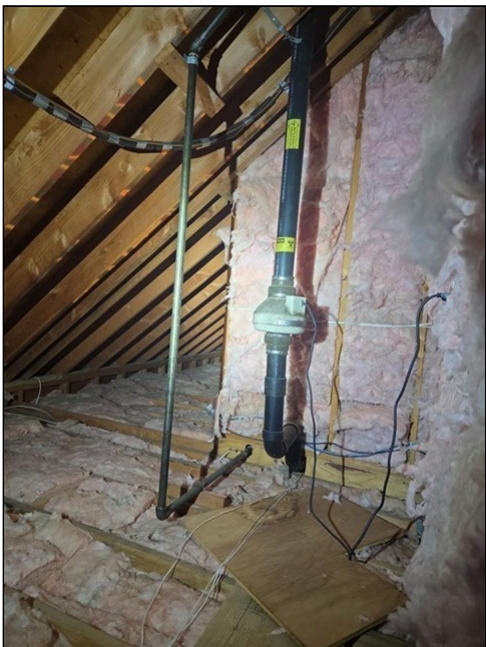
Two radon mitigation systems were observed at the property. The systems were not inspected or evaluated as part of this home inspection, as testing or evaluation of radon mitigation systems is outside the scope of this inspection. Recommend having both radon mitigation systems inspected and evaluated by a qualified radon mitigation professional to verify proper installation, operation, and performance.

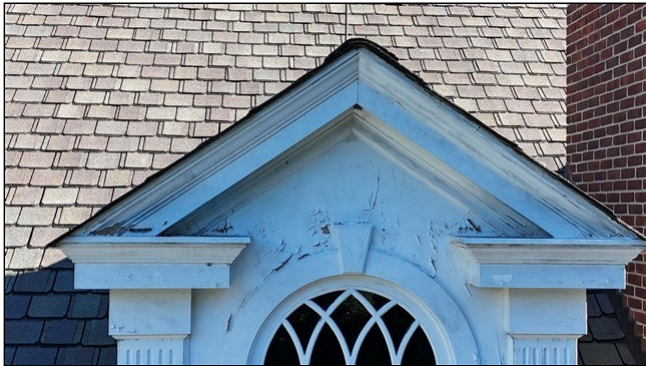
2.0 Item 1(Picture)

The siding has peeling paint at various locations. Further deterioration may occur if not repaired. I recommend a qualified contractor inspect and repair as needed.

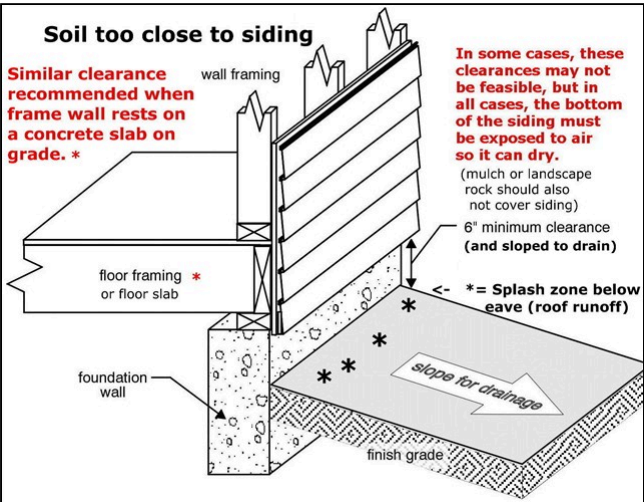
2.4 Item 2(Picture)

There is a negative slope at the exterior and can cause or contribute to water intrusion or deterioration of the foundation. Grading correction is needed by a qualified landscaping contractor prior to closing.

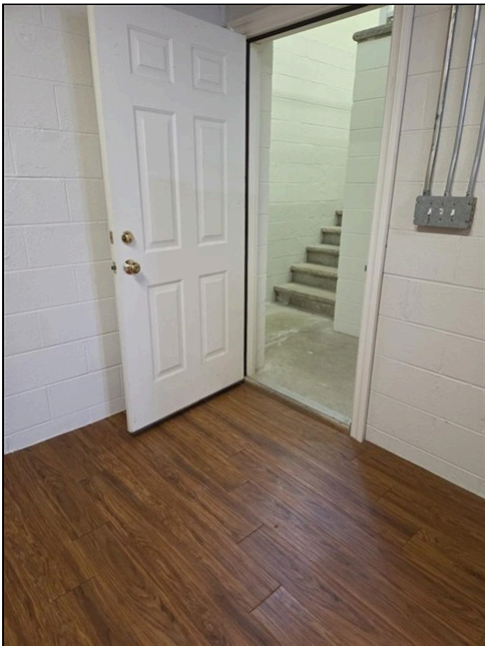
3.4 Item 2(Picture)

The occupant door from inside garage to inside the home is not a self closing, fire rated door. This means that should a fire occur in garage, the occupant door does not afford protection until fireman arrive. This door should be replaced with a fire rated door.

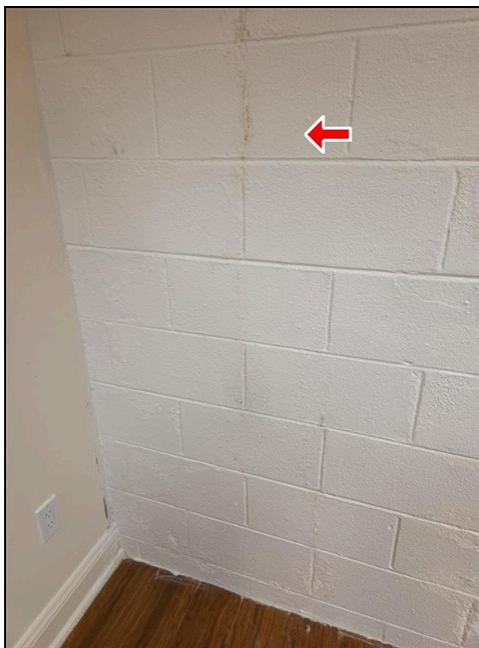
4.2 Item 2(Picture)

At the time of inspection the wall covering revealed a water stain indicating a leak did or still does exist. Water leaks when not repaired can lead to mold or deterioration of building components. Further evaluation by a qualified contractor is needed prior to closing to determine what repairs are needed.

Signs of fungi growth are present on ceiling in several areas. We did not inspect, test or determine if this growth is or is not a health hazard. The underlying cause is moisture or dampness. I recommend you contact a mold inspector or expert for investigation or correction if needed.

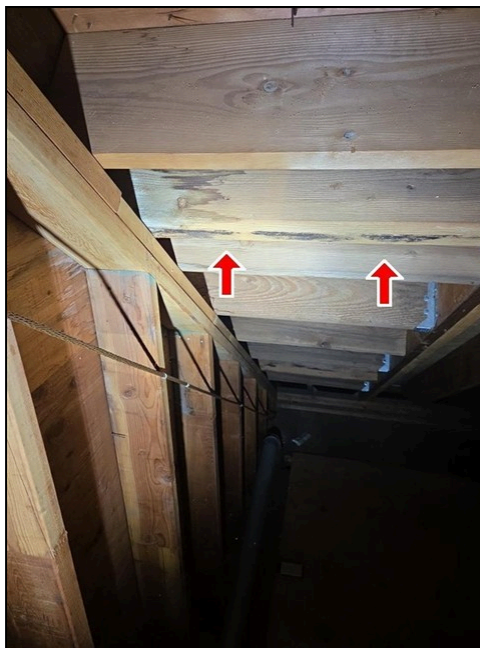
5.4 Item 2(Picture)

(1) The roof sheathing has fungi growth indicating moisture intrusion in areas. Signs of fungi growth indicate that moisture is entering inside the attic. The cause of moisture needs to be found and corrected. We did not inspect, test or determine if this growth is or is not a health hazard. I recommend you contact a mold inspector or expert for investigation or correction if needed.

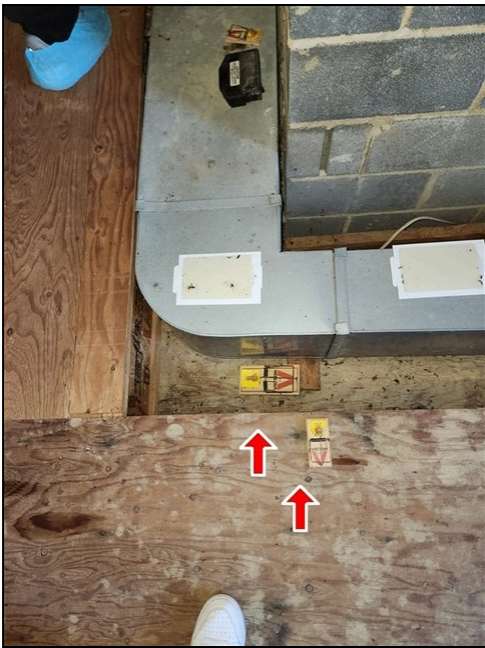
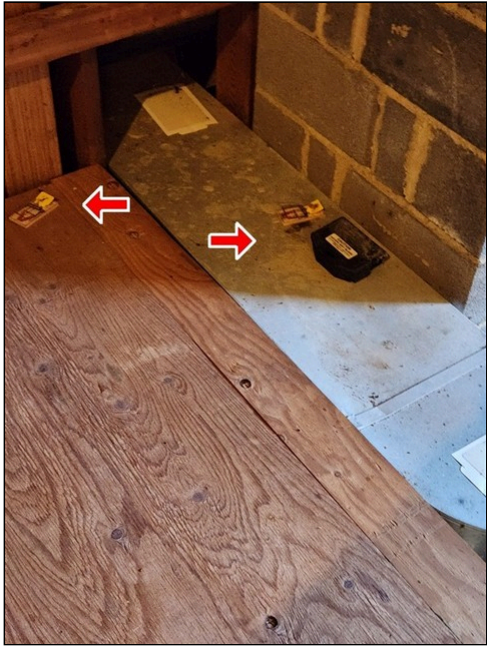
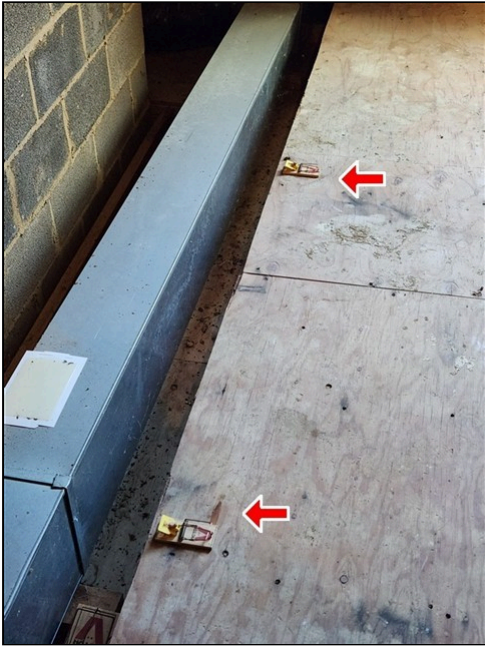
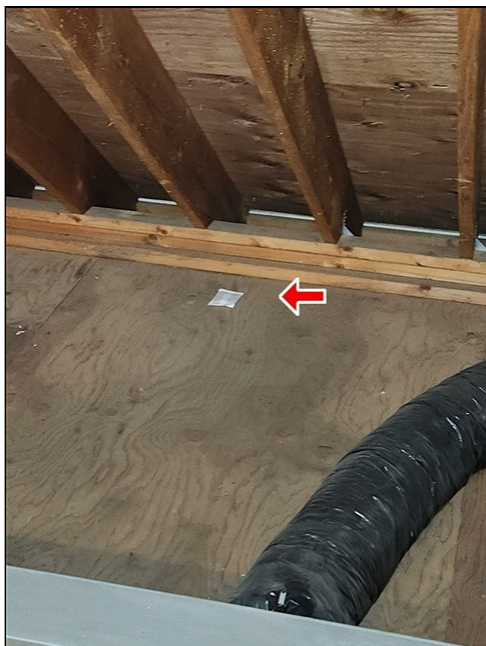
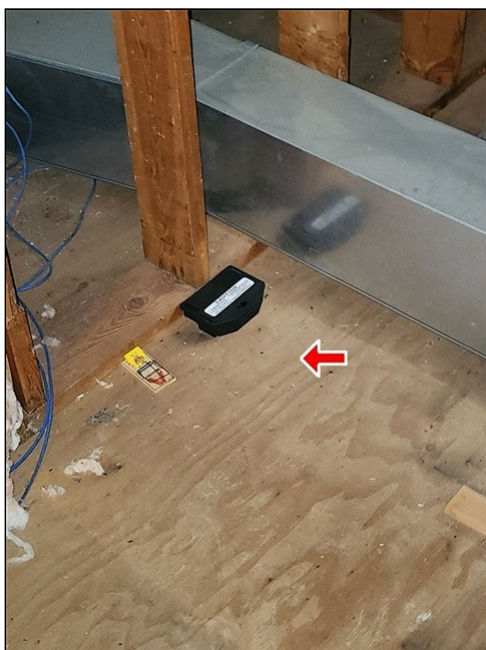
(2) Numerous rodent traps, including traps consistent with mouse and rat control, were observed throughout the attic. A significant amount of rodent fecal matter was also observed in multiple areas. These conditions are indicative of current and/or previous rodent activity.

The extent of the observed evidence suggests that the attic may have experienced significant rodent infestation and/or ongoing pest activity. The source of entry and the extent of any concealed damage could not be determined as part of this visual inspection.

Recommend evaluation by a qualified pest control professional to determine whether active infestation is present, identify and seal potential points of entry, and provide appropriate remediation. Following pest remediation, the attic should be cleaned and sanitized as appropriate. Any insulation or building materials contaminated or damaged by rodent activity should be evaluated for replacement.

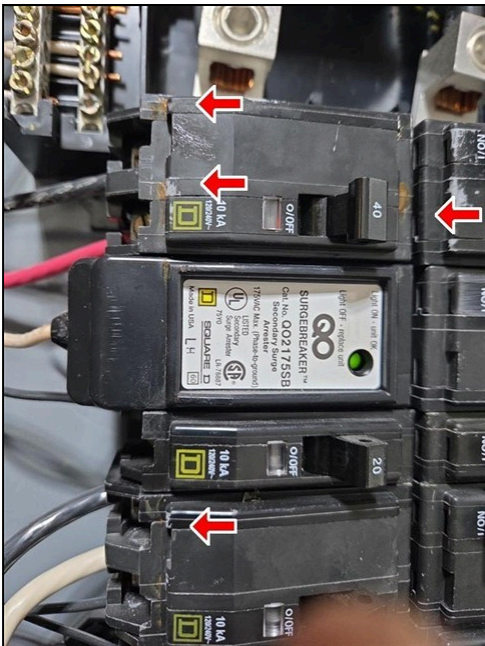
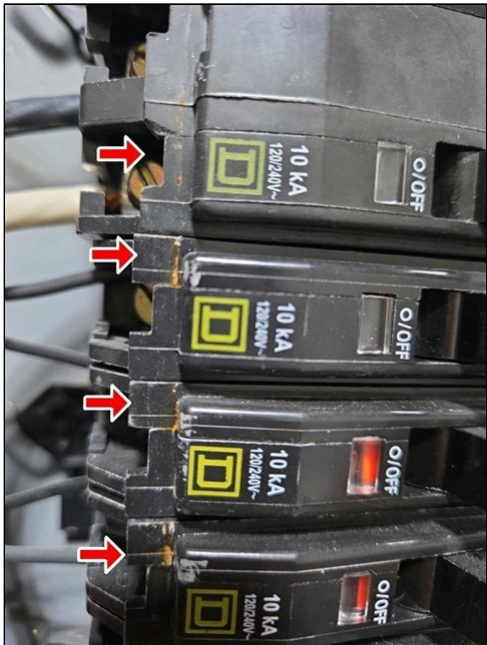
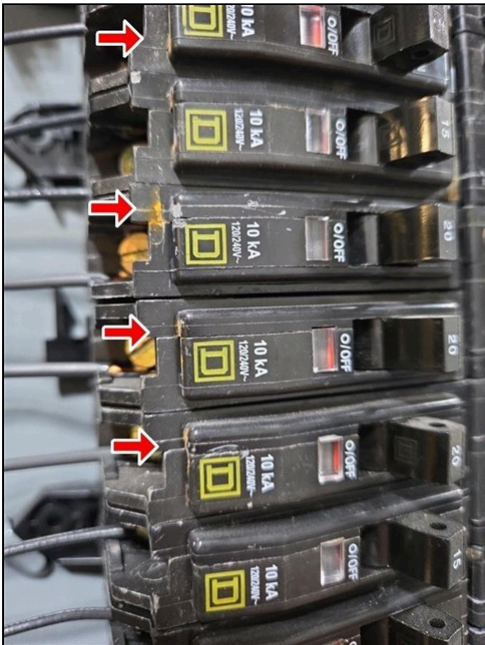
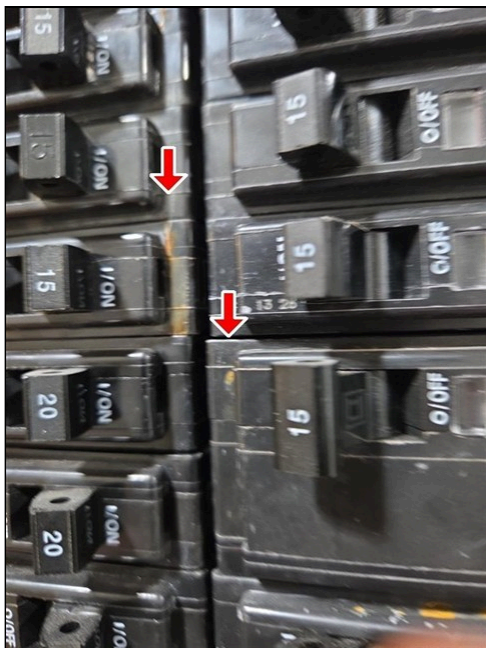
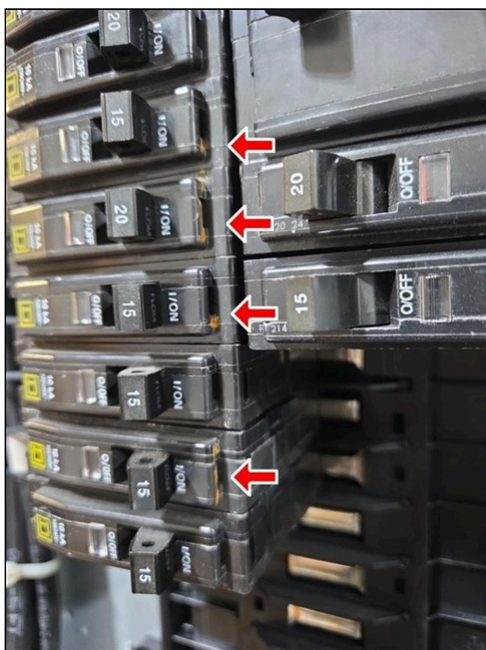
Rust was noted inside the main service panel (labeled panel "B" and panel "E") which is an indication of moisture intrusion. Rust can inhibit circuit breaker performance and may not allow breakers to perform as intended leading to a fire hazard. Further evaluation and repair is needed by a licensed electrician prior to closing.

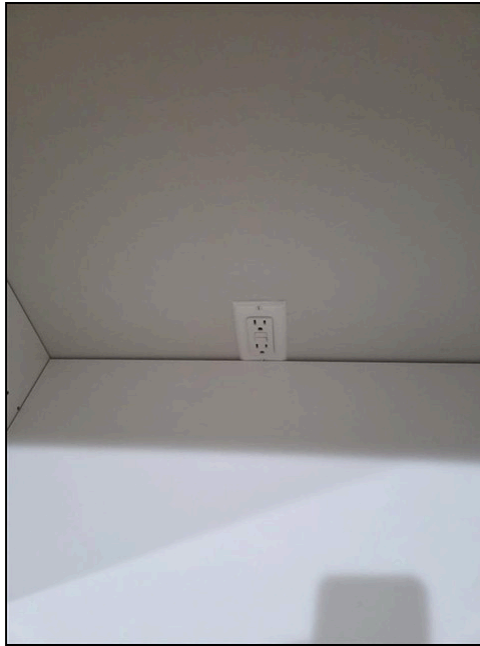
7.3 Item 2(Picture)

Several electrical receptacles were found to be without power at the time of inspection. The cause could not be determined during the inspection. Recommend evaluation by a qualified electrician to determine the cause and make repairs as necessary.

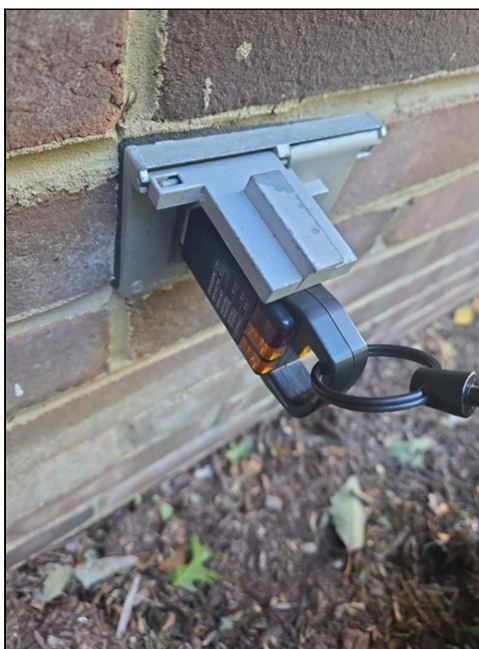
7.5 Item 3(Picture)

(2) Several exterior electrical receptacles were tested and found to have no power at the time of inspection. The cause could not be determined during the inspection. Recommend evaluation by a qualified electrician to determine the cause and restore proper operation. Any exterior receptacles should be properly protected with GFCI protection and weather-resistant covers as applicable.

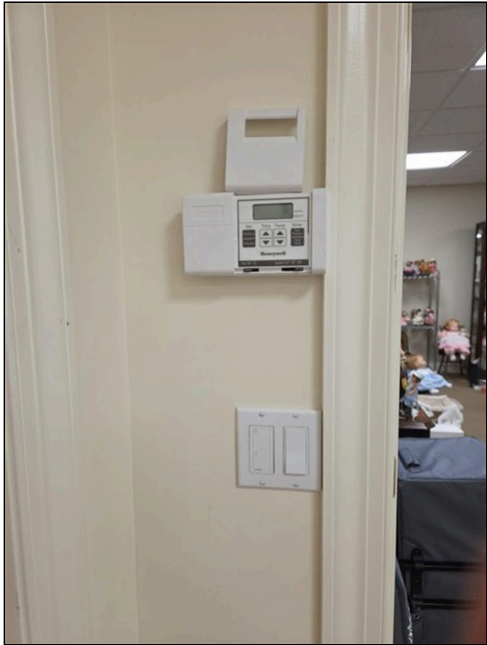
8.2 Item 1(Picture)

The basement heating system could not be operated or inspected at the time of the inspection. The thermostat was not functioning and did not respond to the controls. As a result, the operation and condition of the heating equipment could not be verified. Recommend evaluation by a qualified HVAC contractor to determine the cause of the thermostat malfunction and to inspect and test the basement heating system for proper operation and safety.

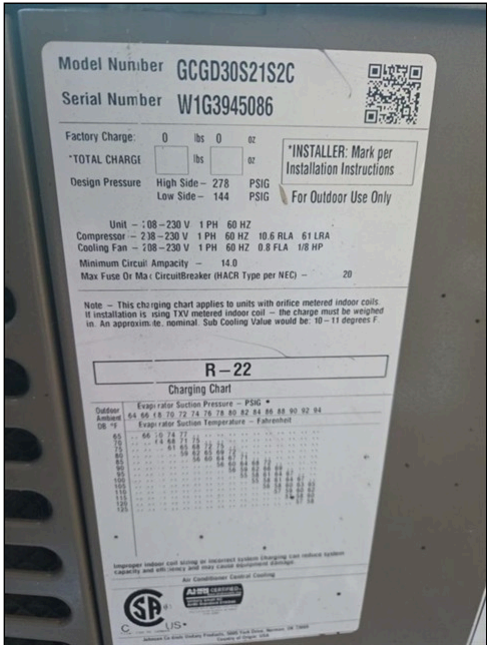
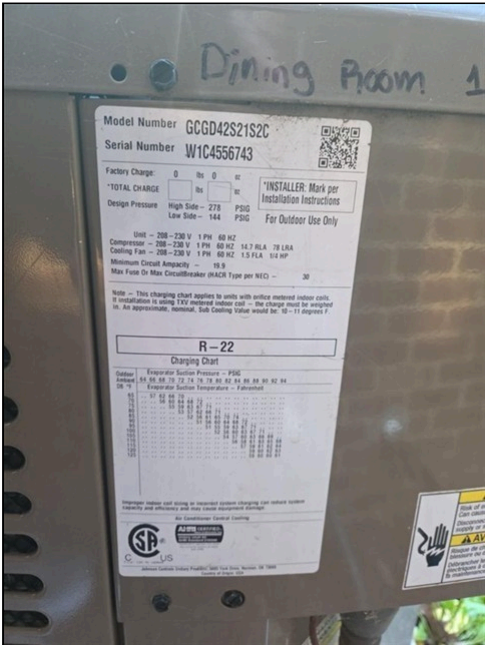
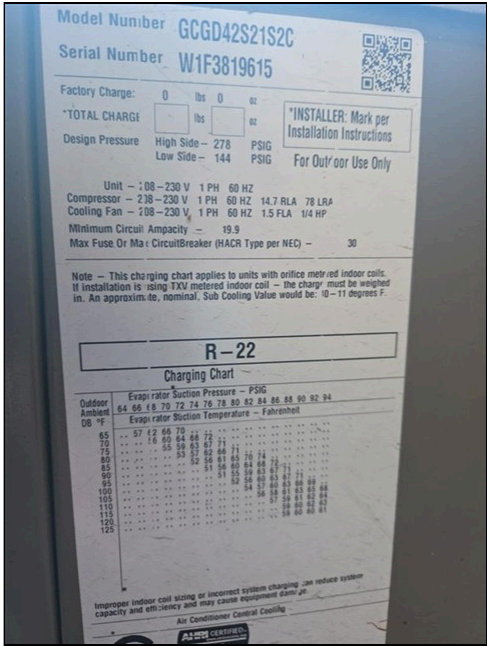
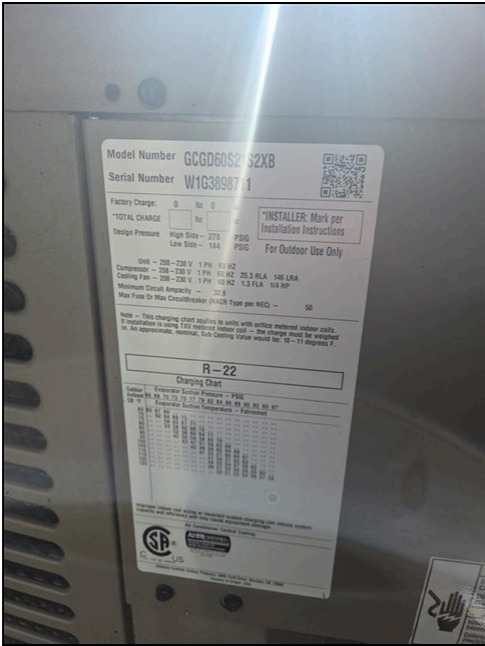
(1) All four air conditioning systems observed at the time of inspection appear to use R-22 refrigerant, which is an older refrigerant no longer manufactured or imported in the United States as of January 1, 2020, due to its harmful environmental effects. It is important to note that systems using R-22 are becoming increasingly expensive and difficult to service due to the limited availability of the refrigerant. While the system may be operational, replacement or modification may be required in the near future. Evaluation by a licensed HVAC technician is recommended to discuss repair options or system upgrade.

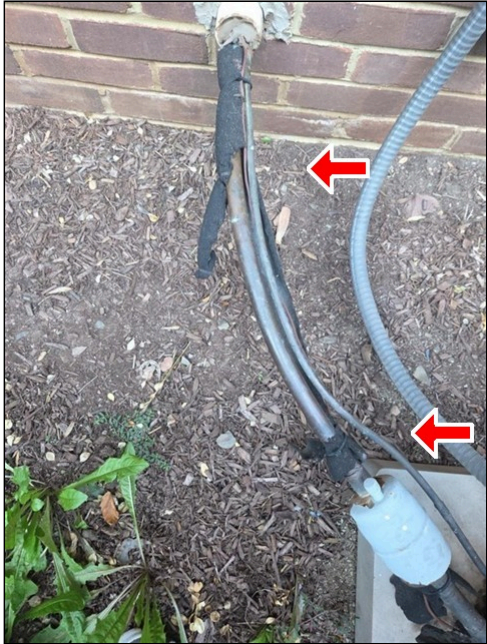
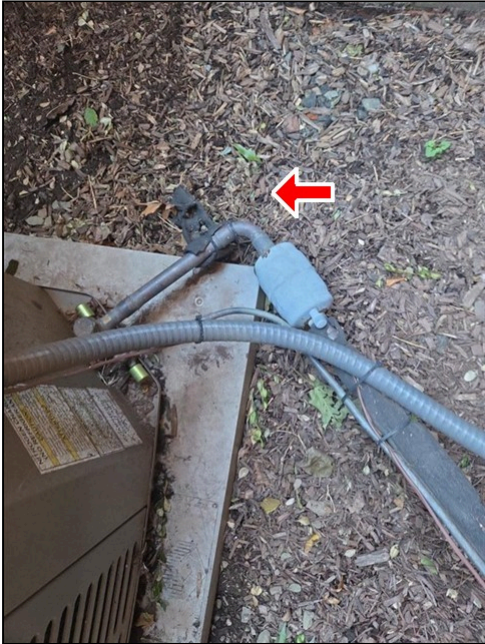
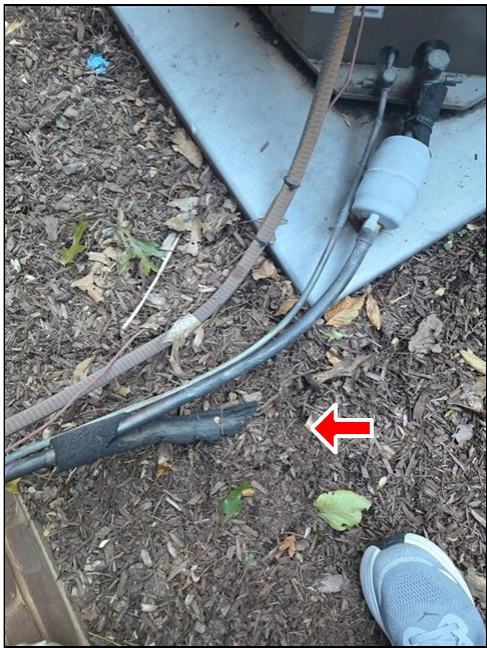
(2) The foam sleeves on suction lines have missing/damaged and deteriorated foam sleeves at outside units. Missing/damaged foam on suction line can cause energy loss and condensation. I recommend service or repair as needed.

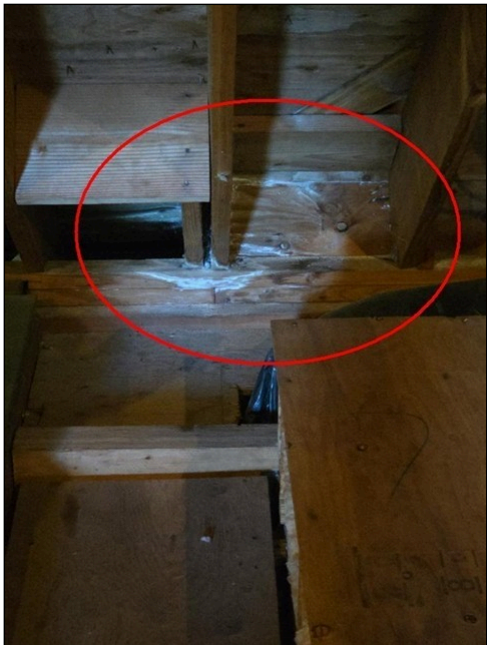
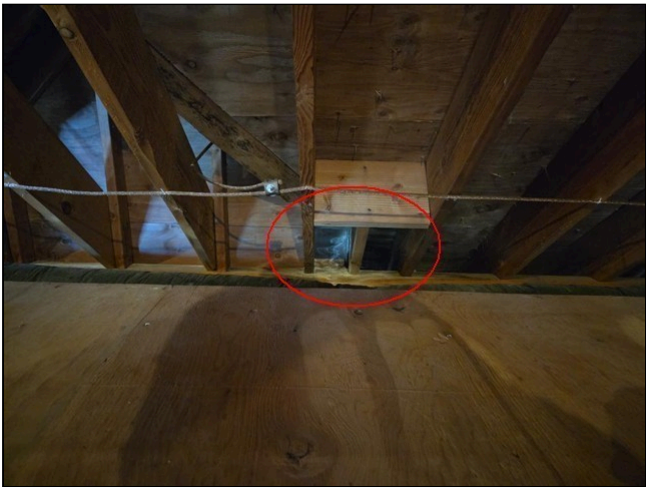
During the inspection of the attic, ventilation appeared to be inadequate, and what may be microbial growth (possible mold) was observed on visible wood surfaces. Poor attic ventilation can trap moisture-laden air leading to condensation and creating conditions conducive to mold or mildew growth. The apparent microbial growth should be evaluated by a qualified environmental specialist, and the attic ventilation system should be reviewed by a qualified contractor to ensure it provides adequate airflow to prevent moisture buildup.
