# Inspection Report

100 My Dream House Lane  
City of Dreams NJ 99999

**Safeway Home Inspections**

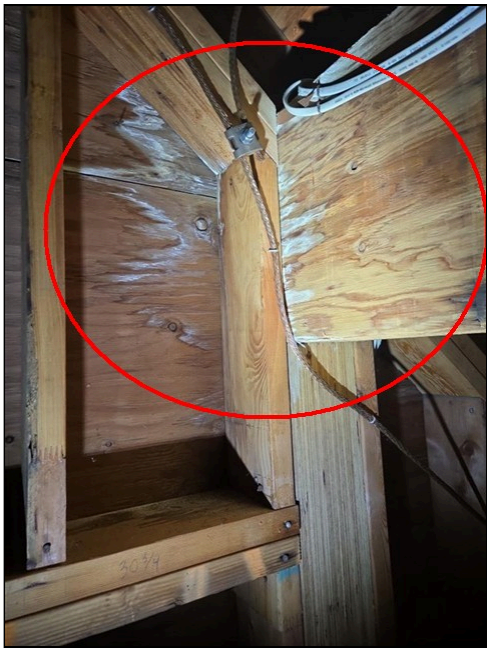
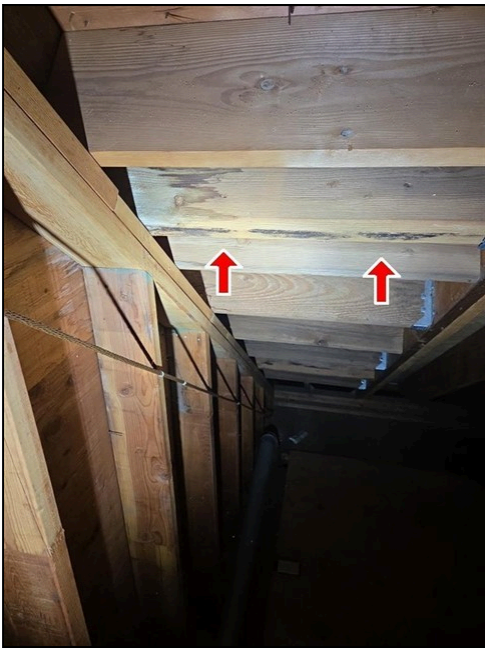
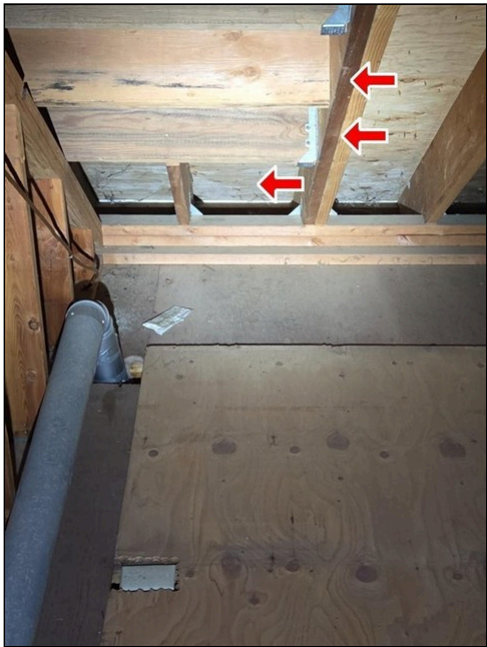
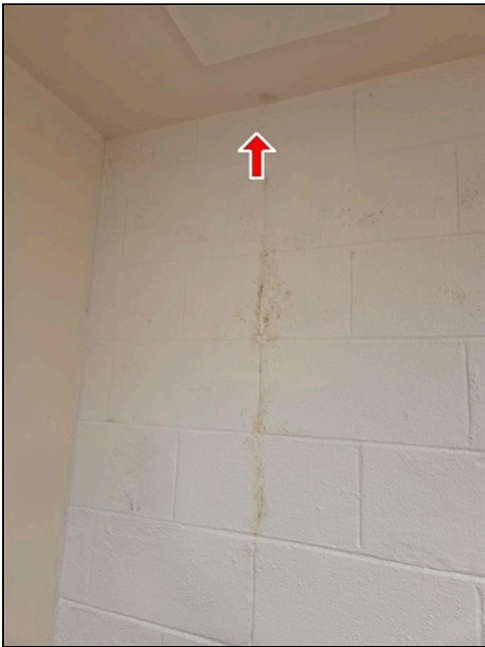
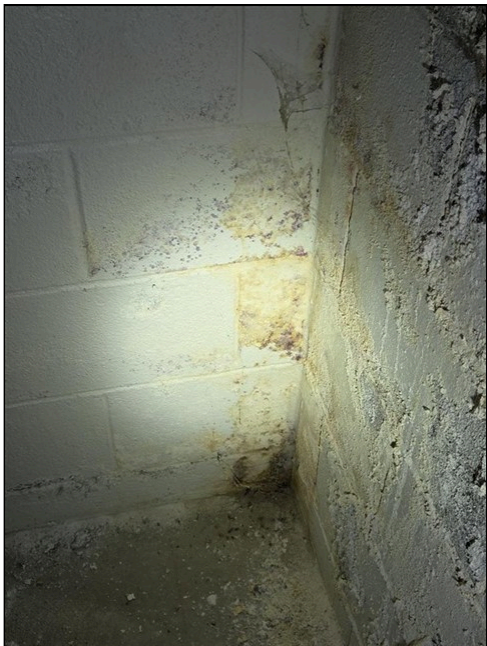
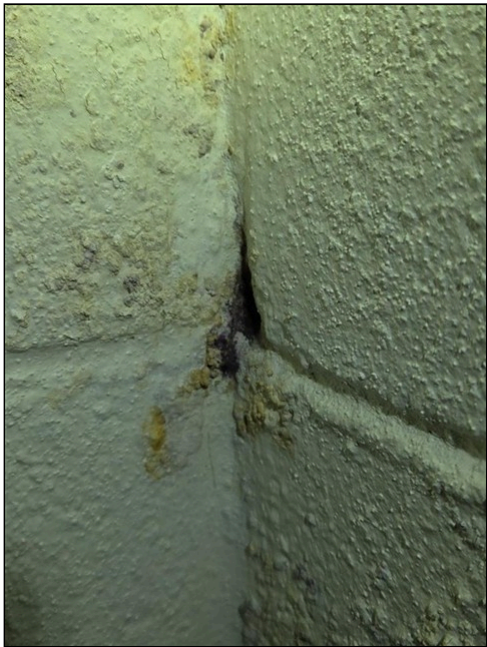
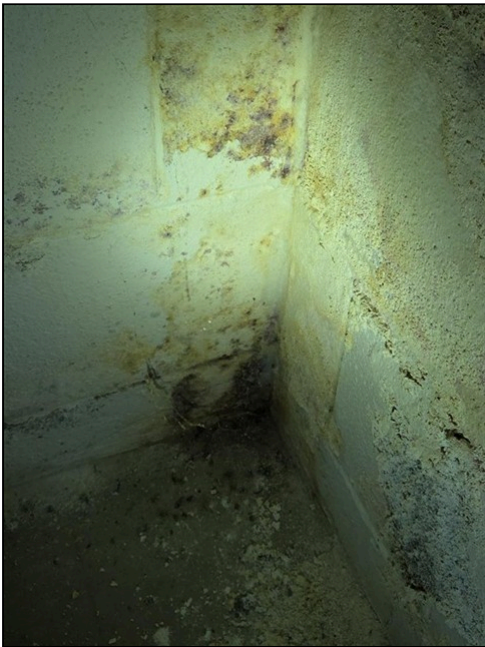
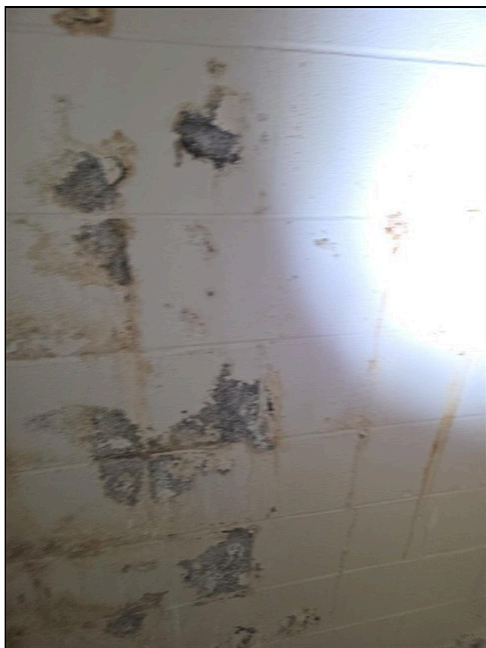
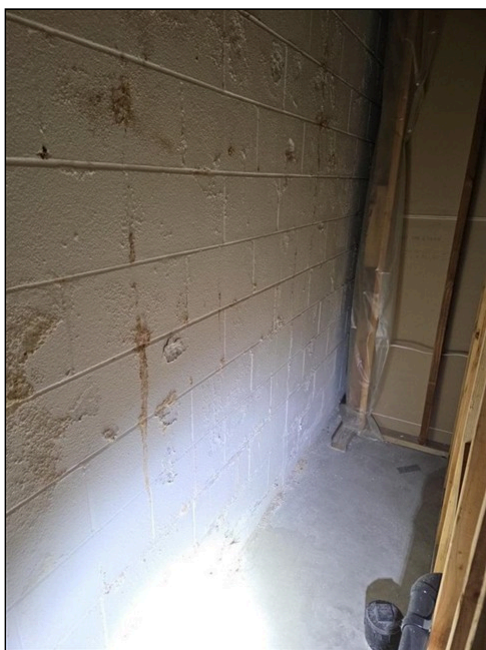
This assessment is limited to readily accessible areas at the time of inspection. Concealed mold and indoor air quality conditions may exist that are not detectable within the scope of this inspection.

Further evaluation and/or remediation is recommended by a qualified and licensed mold assessor or remediation contractor.

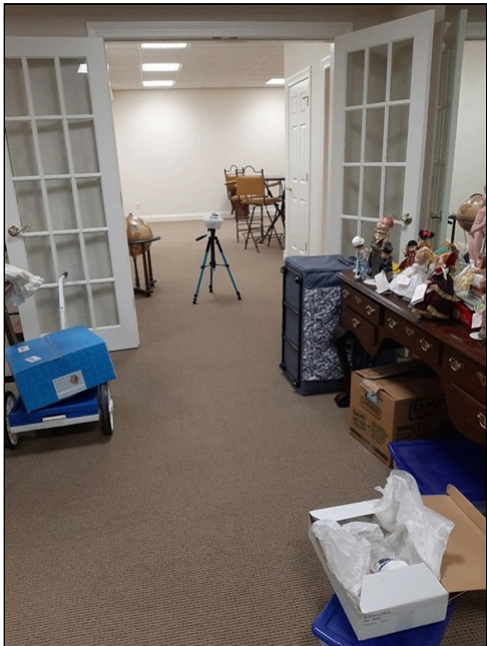
13.1 Item 3(Picture)

Laboratory results indicate that airborne mold spore levels were found to be within normal background ranges when compared to typical indoor and outdoor environments. No unusually elevated concentrations of mold spores were identified in the sampled areas at the time of testing.

While the results are considered normal, maintaining proper moisture control, ventilation, and routine property maintenance is recommended to help prevent mold growth.

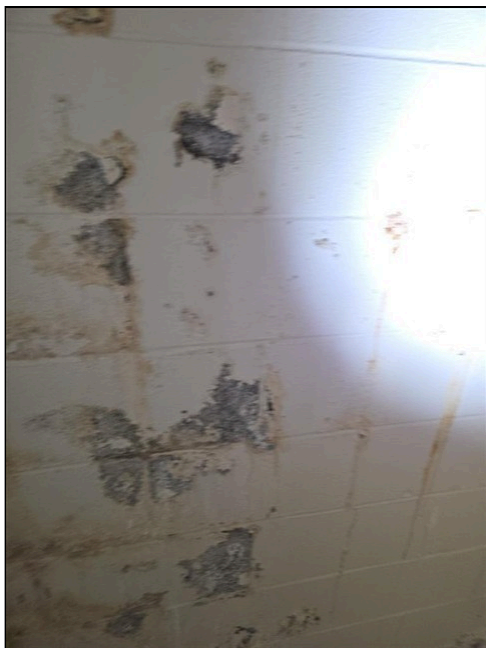
13.2 Item 1(Picture)

During the visual inspection, visible microbial growth and/or conditions conducive to mold growth were observed in the Basement and Attic.

It is important to note that swab sampling is limited to the specific locations tested and does not determine the full extent of mold contamination. The presence of mold is commonly associated with elevated moisture conditions, past or active water intrusion, or inadequate ventilation.

Based on these findings, further evaluation by a qualified licensed mold remediation professional is recommended to determine the extent of contamination and to develop an appropriate remediation plan. Correction of any underlying moisture sources is essential to prevent recurrence.
